## *Representative Architectural Elements*

by Steven Avdakov, R.A., NCARB and Deborah Griffin, Heritage Architectural Associates

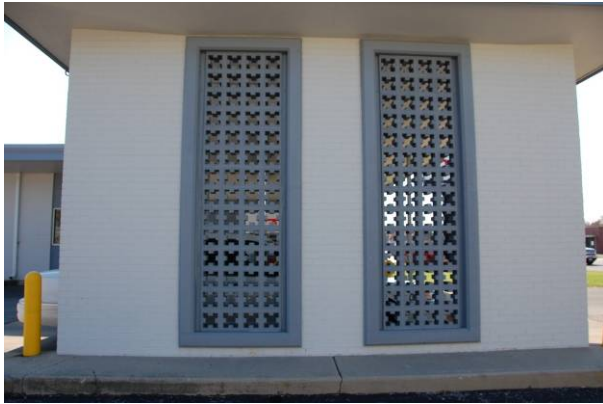
Ornamental concrete block was usually square with decorative patterns and voids and was used to form a screen. Although more common in non-residential settings, this treatment was also found in some houses.

**Screen integrated into façade**  
Vandalia State Bank (1950)  
4600 N. Dixie Dr., Dayton  
MOT-05407-09

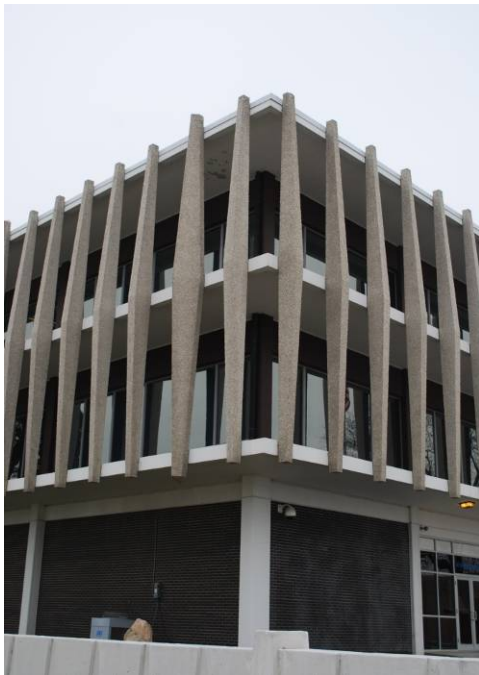
Globe Motors (1968)  
2275 Stanley Ave., Dayton  
MOT-05513-50

Pre-cast concrete allowed the use of non-rectangular sculptural forms. It was observed on a few buildings, primarily of the New Formalism style.

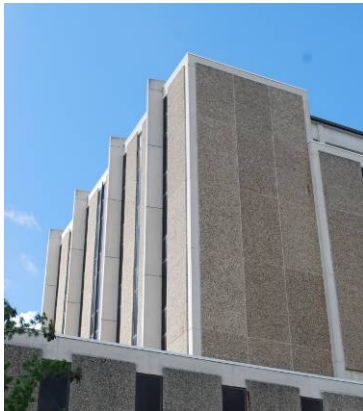
An exposed aggregate concrete finish is created by removing the outer layer of cement paste to reveal the aggregate layer beneath. Aggregates may be mixed into the concrete, seeded into placed concrete, or mixed with a topping material and applied as an overlay. Aggregate size, shape and color determine the appearance of the final product. Several examples of exposed aggregate finish were observed in the surveyed properties. This finish was seen mostly in walls and spandrel panels. Aggregate materials included rock chips, pebbles and pea gravel; colors were generally beige, tan or golden.

**Curtain wall system**  
Roesch Library,  
University of Dayton (1969)  
300 College Park Ave., Dayton  
MOT-05158-60

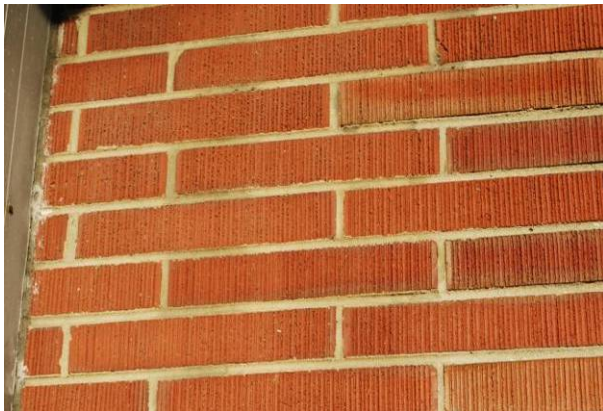
**Elongated with scored finish**  
1711 E. 3rd St., Dayton (ca. 1960)  
MOT-05269-57

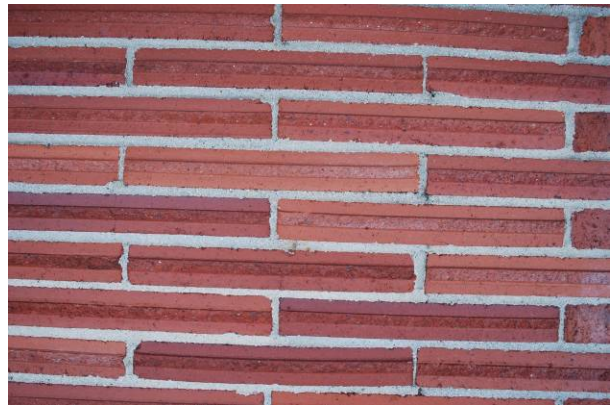
**Elongated with rusticated horizontal band**  
5764 Barbanna Ln., Trotwood (1955)  
MOT-05521-08

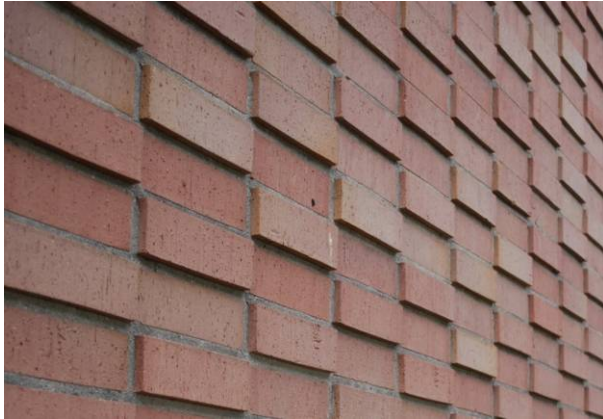
**Alternating projecting pattern**  
Fairview Baptist Church (1965)  
6401 N. Main St., Dayton  
MOT-05332-09

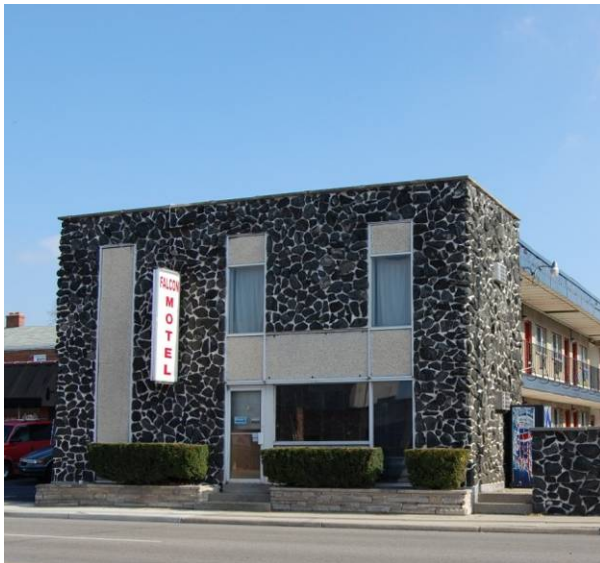
Lava rock was a popular stylistic treatment in the Modern era. It was found in panels and as a wall cladding. This treatment was found on a few residential and non-residential buildings, but it was not common.

**Lava rubble used as wall cladding**  
Falcon Motel (1967)  
36 N. Broad St., Fairborn  
GRE-01205-10

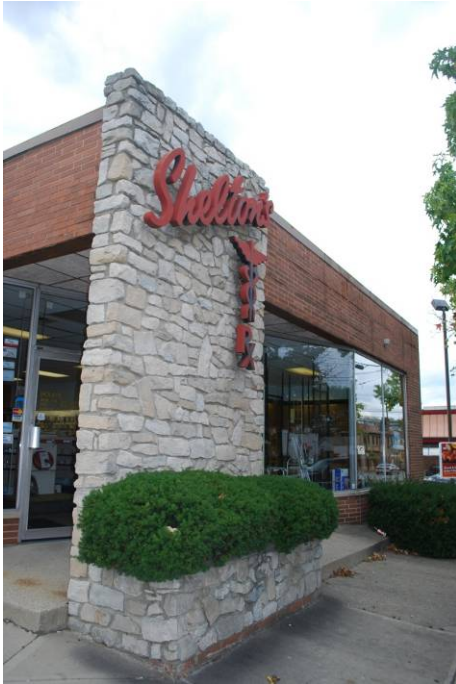
Stone was a traditional material that was used in new ways. Large rubble stone walls or piers were used as a contrast to the surrounding materials. This feature was observed on several buildings in the survey.

**Large panel and planter**  
Shelton Pharmacy (1962)  
1525 Wayne Ave., Dayton  
MOT-05205-60

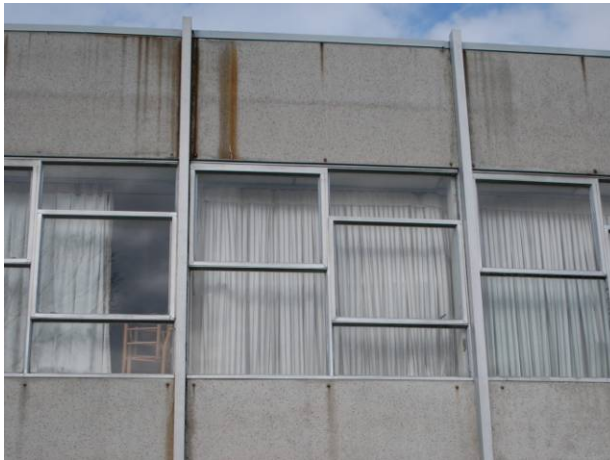
**Extruded mullions**  
Fairview Baptist Church (1965)  
6401 N. Main St., Dayton  
MOT-05332-09

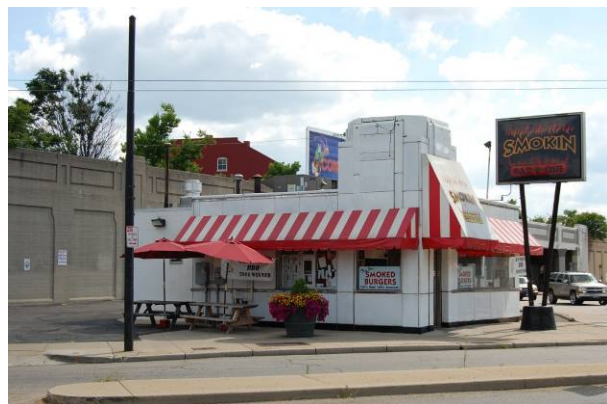
**Panel cladding**  
White Tower (1940-42)  
200 E. Fifth St., Dayton  
MOT-05156-15

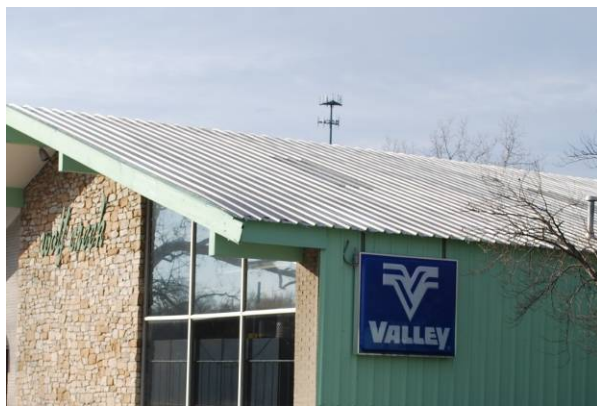
Wolf Creek Company (1962)  
6051 Wolf Creek Pike, Trotwood  
MOT-05482-08

Steel roofing was observed on several non-residential buildings in the survey. Almost all examples were standing seam roofing.

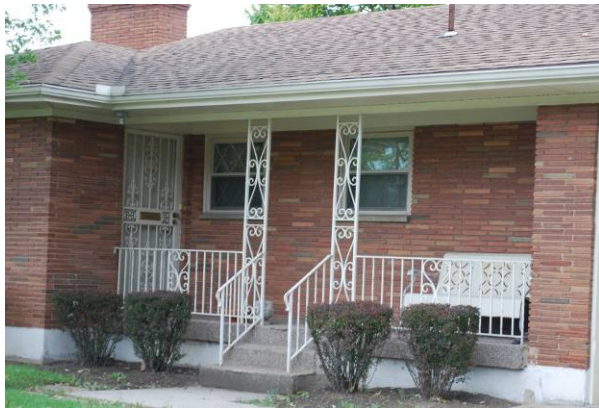
Decorative wrought iron was used extensively in Modern-era residential properties, primarily as porch elements and screen doors. This porch treatment was observed in many types of homes, including Cape Cod cottage, Ranch and homes with no distinctive type or style. The use of decorative wrought iron was found to have extended from the early 1940s until the mid-late 1960s. During the same time period, wrought iron was also used as a railing material in multi-story apartments and motels in the Dayton area.

**Porch elements, including screen door**  
1643 Academy Pl., Dayton (1958)  
MOT-05232-36

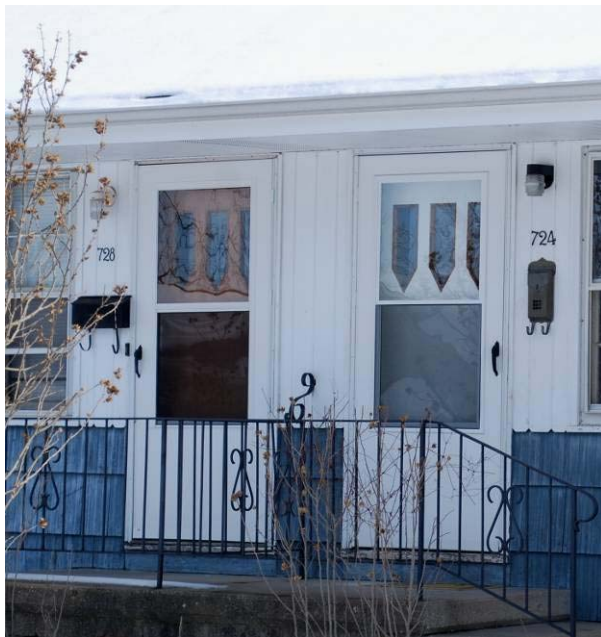
Blonde wooden entrance doors were commonly found on houses of the 1940s and 1950s. These doors usually had one to three lights, often in diamond or rectangular shapes. A large number of houses retain these original front doors, although some have been painted. Double entrance doors were sometimes found on houses built in the 1960s.

**Residential entrance – blonde and painted**  
724-728 Adams St., Fairborn (1954)  
GRE-01196-10

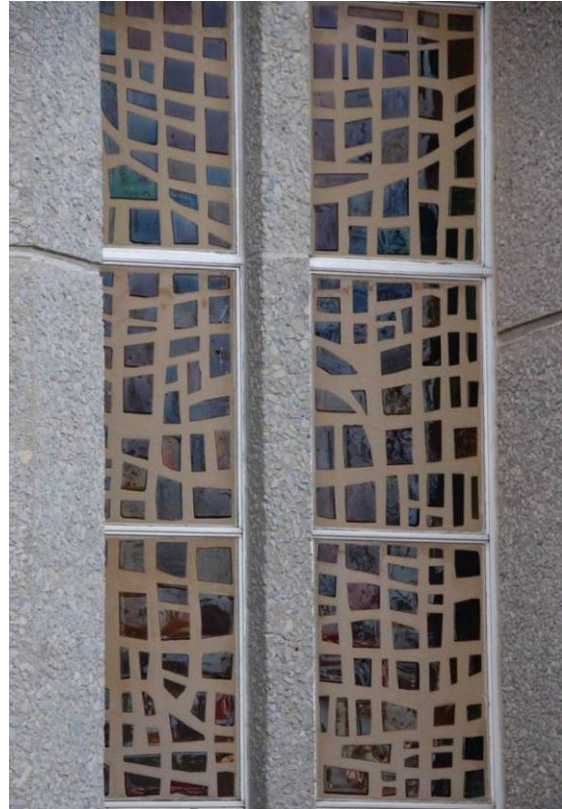
***Dalle de verre* - detail**  
Church of the Incarnation (1969)  
7415 Far Hills Ave., Dayton  
MOT-05593-03

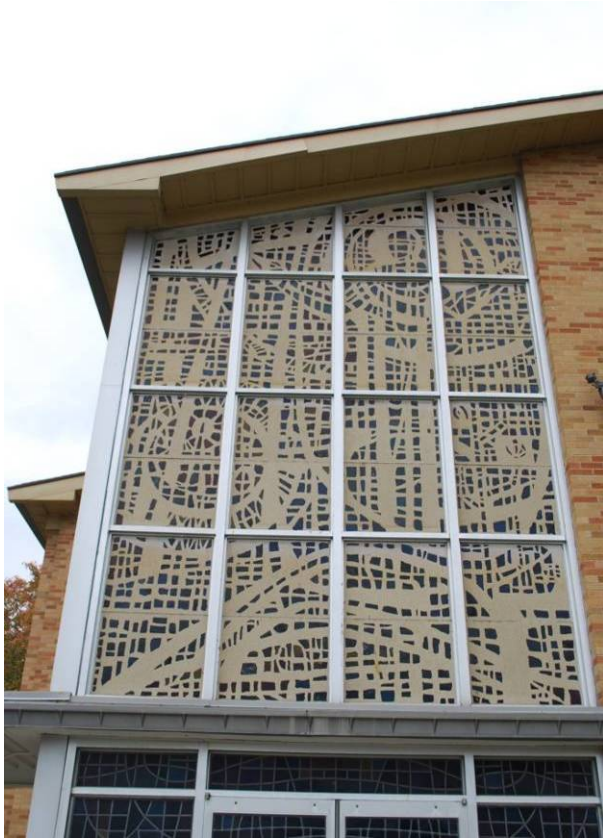
***Dalle de Verre - curtain wall***  
St. Rita's Catholic Church (1964)  
5401 N. Main St., Dayton  
MOT-05335-09

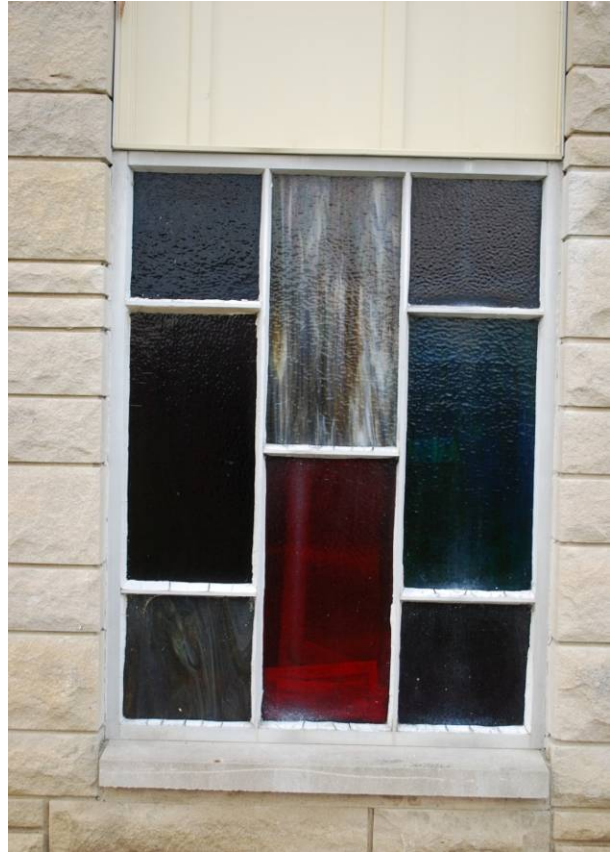
**Colored offset lights**  
First Church of the Nazarene (1964)  
7031 N. Main St., Dayton  
MOT-05330-09

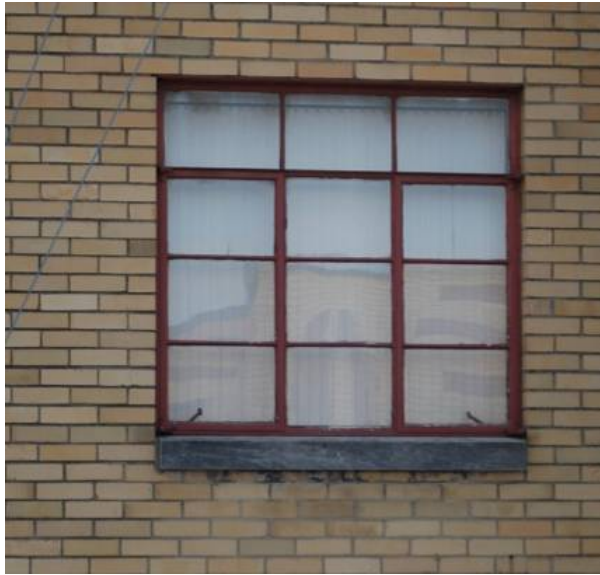
Trailmobile (1949)  
1749 Stanley Ave., Dayton  
MOT-05505-48

Steel casement windows were observed in both residential and non-residential settings in Dayton. These types of windows were mostly found in buildings dating from the 1940s and 1950s. By the late 1950s, aluminum generally had replaced steel as a window framing material.

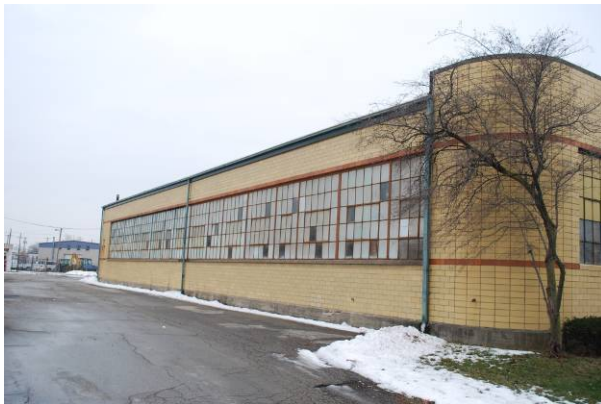
PMF Associates (1946)  
1280 McCook Ave., Dayton  
MOT-05508-48

Steel windows were found on earlier 1940s buildings. The survey results indicate that steel had been replaced with aluminum-framed windows by the mid- to late 1950s.

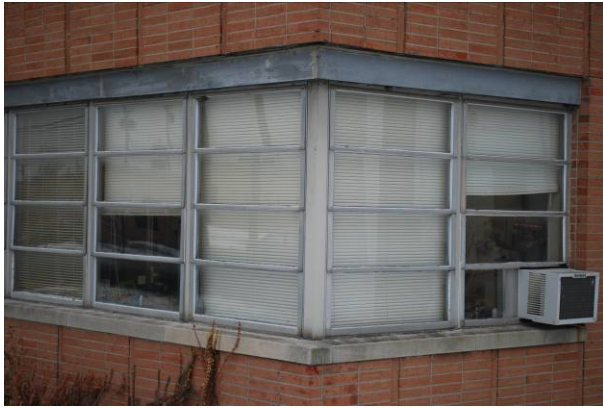
**Continuous - turning corner**  
General Diaper Service (1955)  
1407 Stanley Ave., Dayton  
MOT-05506-48

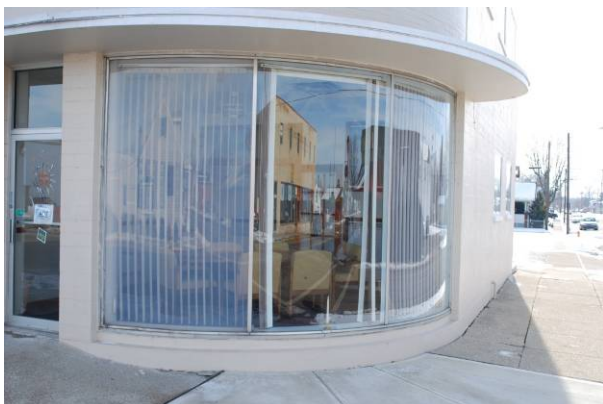
440 W. Main St., Fairborn (1949)  
GRE-01192-10

Only one curved glass window was observed in the survey area. Rounded corners in other Art Moderne buildings were usually filled with glass block.

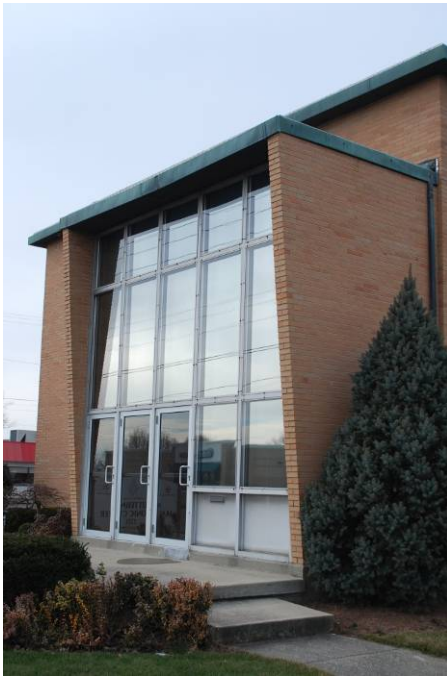
Glazed aluminum curtain wall was one of most prominent stylistic elements of Modern design. Its clean lines reflected the “machine aesthetic” that was a common theme of Modern styling. Framing systems featured prominent use of aluminum. Spandrels were comprised of many different types of materials, including porcelain enamel, exposed aggregate reinforced concrete, and ceramic tile. Curtain wall systems were found in many non-residential buildings in the Dayton area.

**With entrance system**  
Kettering Masonic Center (1958)  
2251 S. Smithville, Kettering  
MOT-05503-06

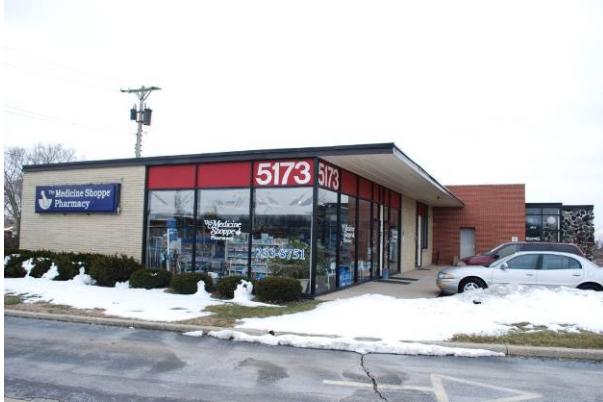
Storefront systems consist of glass entrance doors with metal framing that are surrounded by glass panels. These systems were found not only on retail establishments, but as entrances to churches, schools, and office buildings.

**With porcelain enamel metal spandrel panels**  
Brandt Medical Center (1963)  
5173 Brandt Pike, Huber Heights  
MOT-05520-14

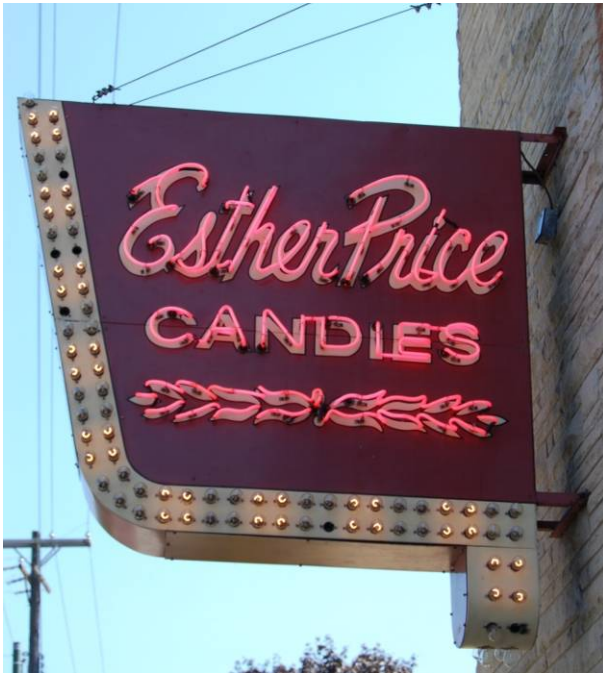
By 1940, exposed light bulb and neon signs had been in use for many years. Both types featured lights attached to a hollow-core metal base. Neon was popular due to the malleable quality of the neon tubing and wide variety of colors. Despite the popularity of neon, the exposed light bulb remained an important element of mid-20<sup>th</sup>-century signs. Many sign manufacturers took advantage of both lighting technologies well into the 1960s. Both neon and exposed light bulb signs were found in the survey.

**Combination neon and exposed light bulb**  
Esther Price Candies (1952)  
1709 Wayne Ave., Dayton  
MOT-05195-60

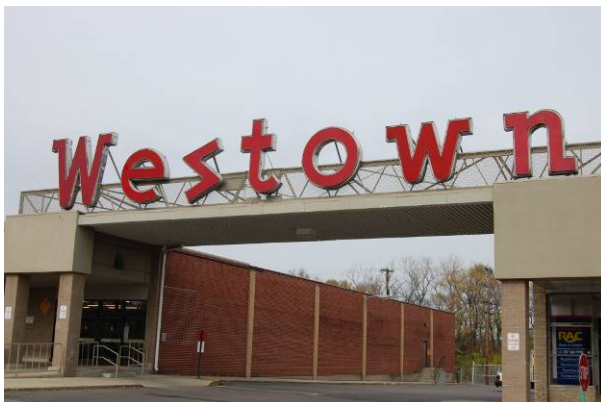
Plastics for signs began to be used in the late 1940s and remained a staple of sign construction through the 1970s. Plastic panels, whether or not back-lit, also provided the ability to create a sign's wording with individual letters. This allowed signs to take on even greater dynamic proportions and irregularity in shape. Hollow-core metal sections were sometimes intermixed with plastic hollow-core sections. A number of period plastic and metal hollow core signs were observed in the survey area.

**Plastic hollow core – individual letters**  
 Westtown Shopping Center (1957)  
 4227 W. Third St., Dayton  
 MOT-05300-32

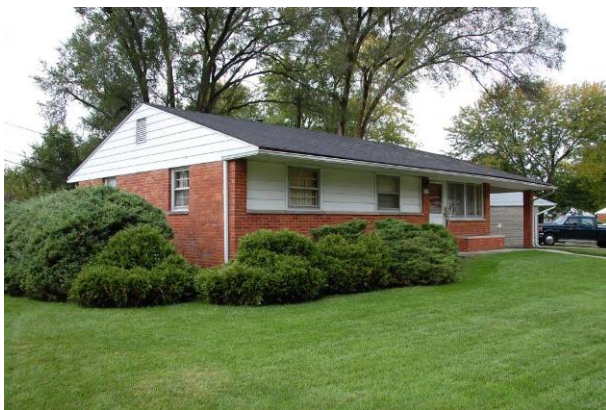
2315 Hickorydale Dr., Dayton (1956)  
MOT-05367-39

Two nearly identical houses in the Northern Hills neighborhood, Dayton, illustrate the difference that replacement windows can have on the appearance of a basic Ranch house. The house at 2315 Hickorydale Drive retains its paired horizontal-slider picture window and wood two-over-two windows, but the house at 2446 Marchmont Drive has had vinyl replacement windows installed.

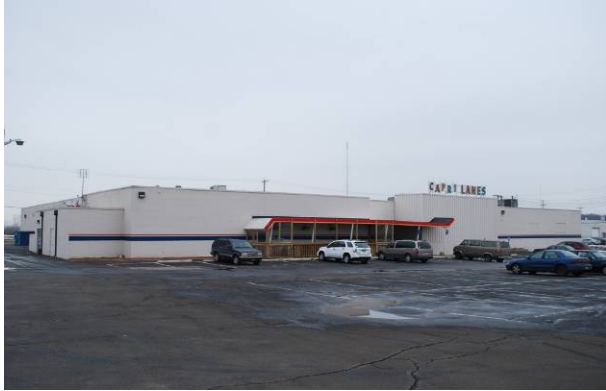
Capri Lanes (1959)  
2727 S. Dixie Hwy., Kettering  
MOT-05497-06

Two examples of commercial buildings that have lost their historic integrity and would not qualify for National Register listing are the Capri Lanes and the Hasty Tasty Drive-in. Coincidentally, both enterprises do retain their historic roadside signs. The Capri Lanes is only moderately intact. The masonry has been painted, and part of the entrance canopy has been enclosed with modern materials. Two horizontal windows on the front façade have been covered. The Hasty Tasty Drive-in has been dramatically altered with additions, a new roof configuration, and the replacement of storefront windows. As a result, it now has a late 20<sup>th</sup>-century appearance.
