Representative Architectural Elements

by Steven Avdakov, R.A., NCARB and Deborah Griffin, Heritage Architectural Associates

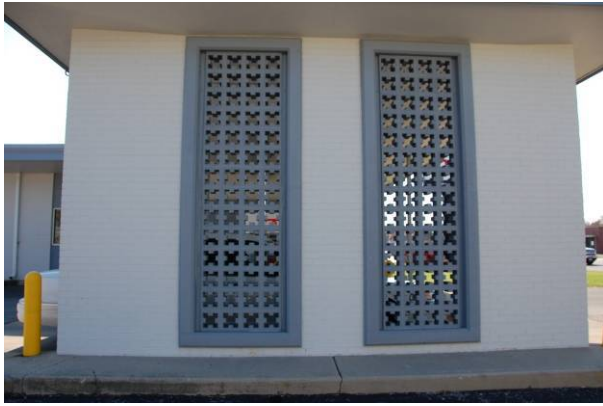
Ornamental concrete block was usually square with decorative patterns and voids and was used to form a screen. Although more common in non-residential settings, this treatment was also found in some houses.

Screen integrated into façade
Vandalia State Bank (1950)
4600 N. Dixie Dr., Dayton
MOT-05407-09

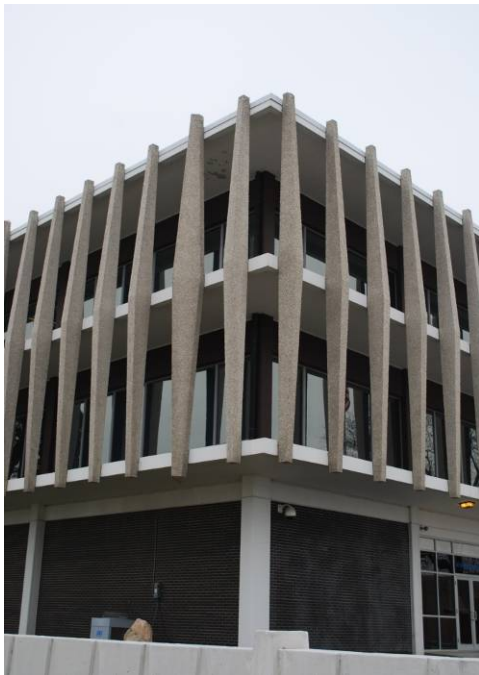
Globe Motors (1968)
2275 Stanley Ave., Dayton
MOT-05513-50

Pre-cast concrete allowed the use of non-rectangular sculptural forms. It was observed on a few buildings, primarily of the New Formalism style.

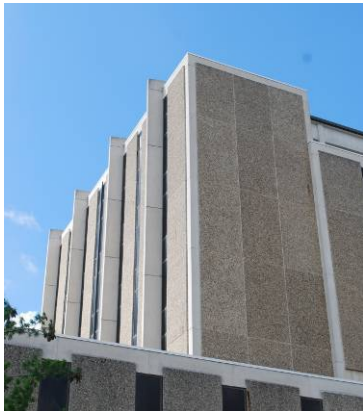
An exposed aggregate concrete finish is created by removing the outer layer of cement paste to reveal the aggregate layer beneath. Aggregates may be mixed into the concrete, seeded into placed concrete, or mixed with a topping material and applied as an overlay. Aggregate size, shape and color determine the appearance of the final product. Several examples of exposed aggregate finish were observed in the surveyed properties. This finish was seen mostly in walls and spandrel panels. Aggregate materials included rock chips, pebbles and pea gravel; colors were generally beige, tan or golden.

Curtain wall system
Roesch Library,
University of Dayton (1969)
300 College Park Ave., Dayton
MOT-05158-60

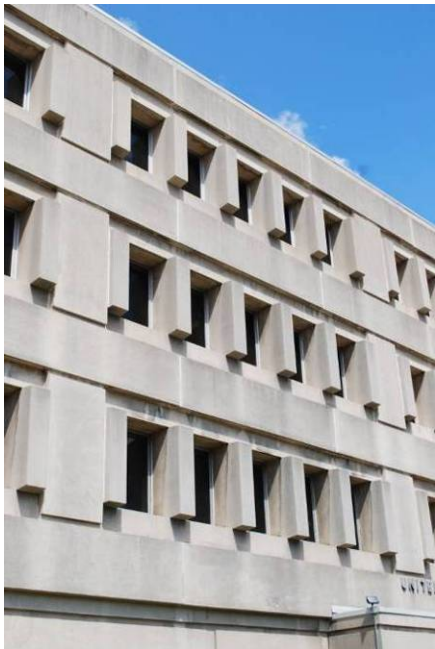
United States Post Office (1970)
1111 E. Fifth St., Dayton
MOT-05160-57

Large pre-cast concrete panels were thick, boxy forms used on buildings that were weighty and massive in form, such as those of the Brutalism style. These panels were seen on a few buildings in the Dayton survey area.

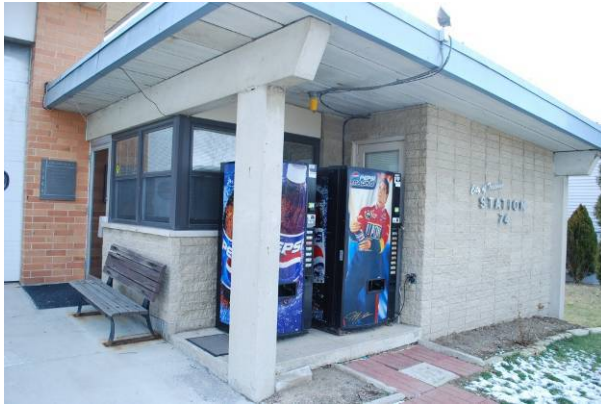
Beams

Pre-stressed concrete was used in structural elements subject to loads, such as beams and slabs. Several examples of concrete structural elements were observed in the surveyed buildings.

Fire Station 74 (1966)
14 W. Trotwood Blvd., Trotwood
MOT-05481-08

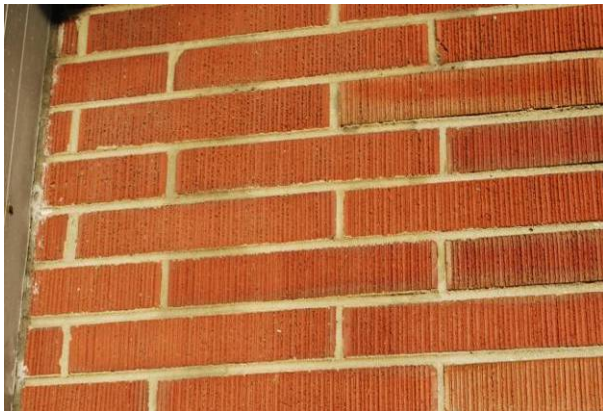
Brick was one of the oldest and most commonly used building materials in the Dayton area, and it continued to be widely used in the Modern era. It was readily available from factories in Ohio and surrounding states. Factories produced standardized pieces, allowing ease of assembly. Modern era brickwork varied from the traditional in color, shapes, finishes, and bonding pattern. Colors included shades of red, orange, buff, yellow, cream, gray, brown and black. Elongated brick was commonly seen, and some featured a rusticated horizontal band. Other finishes included scored, textured, and split face. Bonding patterns included stretcher, offset, stack and projecting, with stretcher and offset the most common. Brick construction of this era was also different than its predecessors. Face brick was manufactured with holes in the top and bottom to ensure even firing. In addition, brick was usually laid as a one-wythe veneer tied to a structural framing system of wood, metal or concrete.

Elongated with scored finish
1711 E. 3rd St., Dayton (ca. 1960)
MOT-05269-57

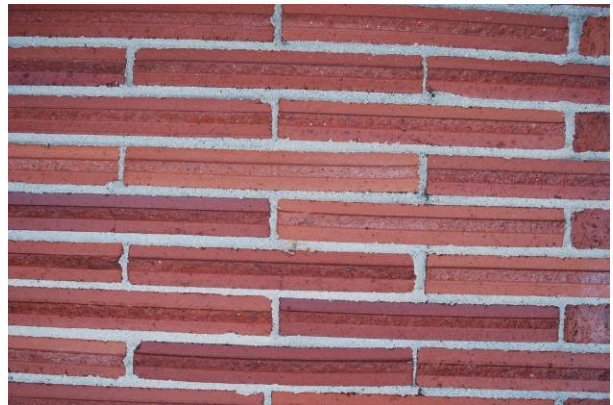
Elongated with rusticated horizontal band
5764 Barbanna Ln., Trotwood (1955)
MOT-05521-08

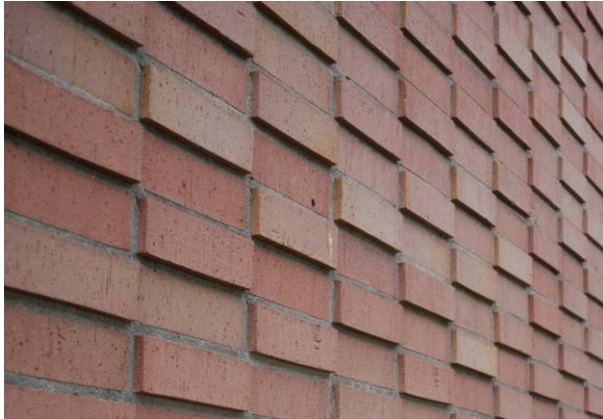
Alternating projecting pattern
Fairview Baptist Church (1965)
6401 N. Main St., Dayton
MOT-05332-09

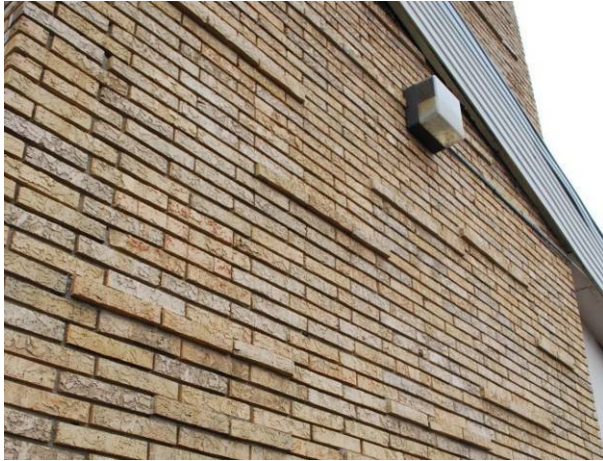
Elongated with offset bond and projecting pattern

Capri Motel & Coffee Shop (1956)
2700 S. Dixie Hwy., Kettering
MOT-05498-06

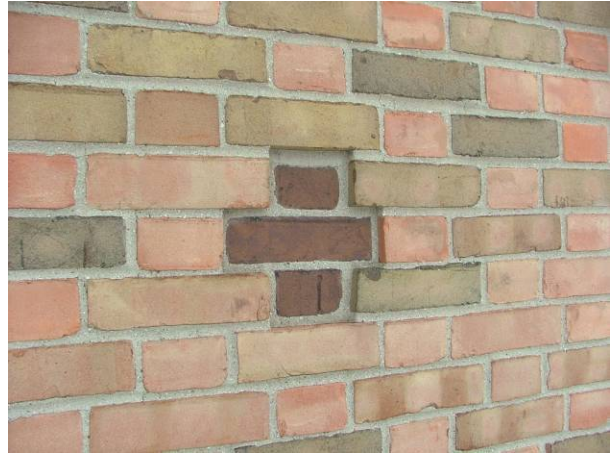
Ornamental treatment with contrast

Vandalia Evangelical United Brethren Church (1963)
200 S. Dixie Dr., Vandalia
MOT-05437-13

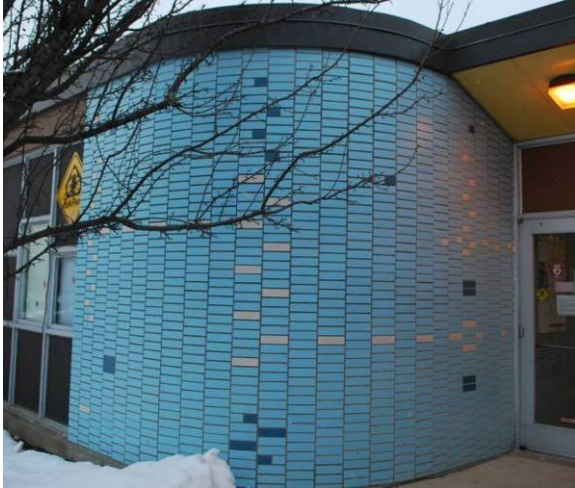
Glazed brick and ceramic block were used for emphasis and accent. The sleekness of appearance reflects attributes of the Modern style. Factory-manufactured standardized pieces ensured quality and ease of assembly. Bricks and blocks were available in different shapes and a variety of colors. Bonding patterns include stretcher, offset and stack. The survey revealed that earlier uses of these materials tended to be as accent striping, though later it was used to fill larger fields.

Large field used to emphasize entrance
 Rushmore Elementary (1964)
 7701 Berchman Dr., Huber Heights
 MOT-05517-14

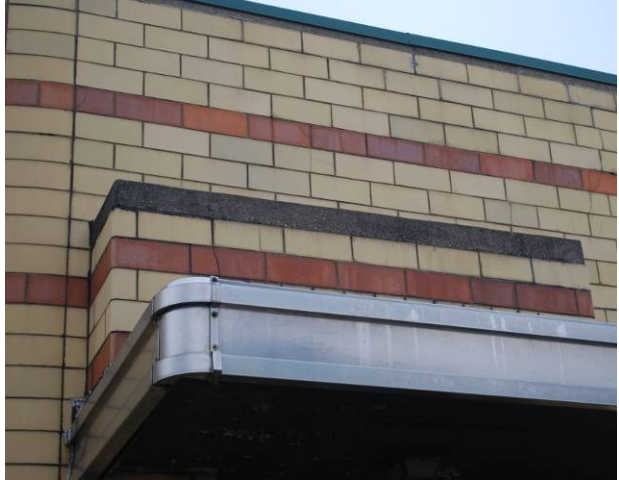
Used as an accent
 PMF Associates (1946)
 1280 McCook Ave., Dayton
 MOT-05508-48

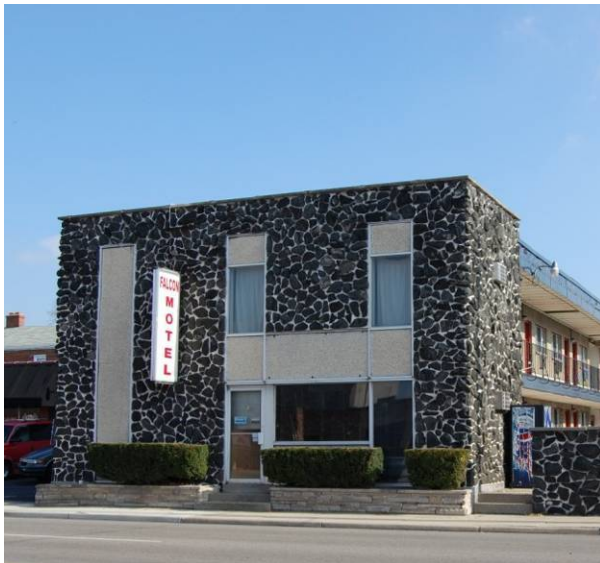
Lava rock was a popular stylistic treatment in the Modern era. It was found in panels and as a wall cladding. This treatment was found on a few residential and non-residential buildings, but it was not common.

Lava rubble used as wall cladding
 Falcon Motel (1967)
 36 N. Broad St., Fairborn
 GRE-01205-10

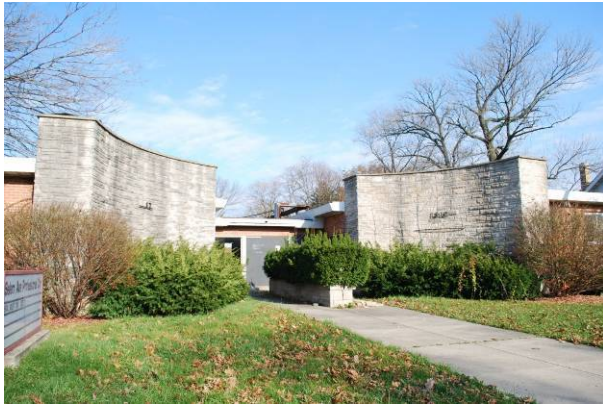
Curved panel

Simulated masonry became a popular treatment during the period because it was more affordable and quicker to install than traditional stone. Concrete products, applied either to lath or directly to other masonry, was formed into a simulated stone using molds and stamps. It was used in both new construction and renovation. Permastone, an Ohio product, was readily available in the Dayton area. Simulated masonry was observed in curved, flat, and accent panels. This treatment was observed on a number of residential and non-residential buildings in the Dayton area.

Salem Professional Center (1957)
1217 Salem Ave., Dayton
MOT-05260-42

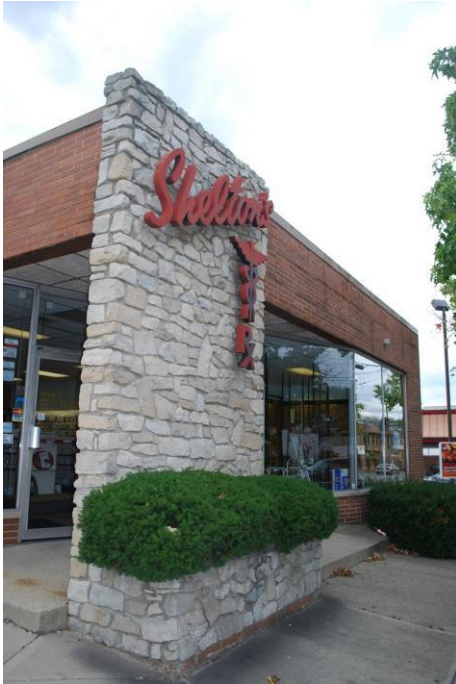
Stone was a traditional material that was used in new ways. Large rubble stone walls or piers were used as a contrast to the surrounding materials. This feature was observed on several buildings in the survey.

Large panel and planter
Shelton Pharmacy (1962)
1525 Wayne Ave., Dayton
MOT-05205-60

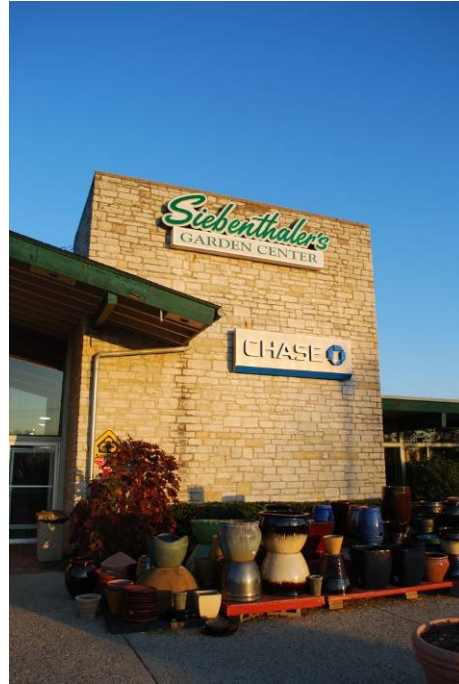
Front wall
Siebenthaler Garden Center (1960)
6000 Far Hills Ave., Centerville
MOT-05218-03

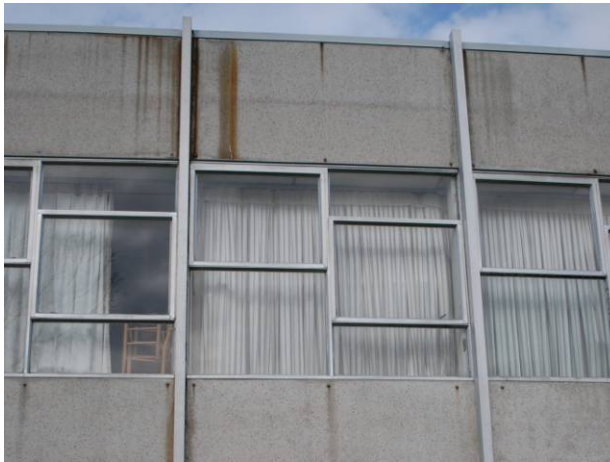
Aluminum “came of age” during the postwar era due to advances in production and cost reduction. It was available in many different finishes as well as being lightweight and resistant to corrosion. The survey revealed extensive use in curtain wall systems and other types of window framing. It was also seen in residential construction, especially in windows and ornamental elements. Aluminum became popular as a replacement siding on older homes during this period.

Extruded mullions
Fairview Baptist Church (1965)
6401 N. Main St., Dayton
MOT-05332-09

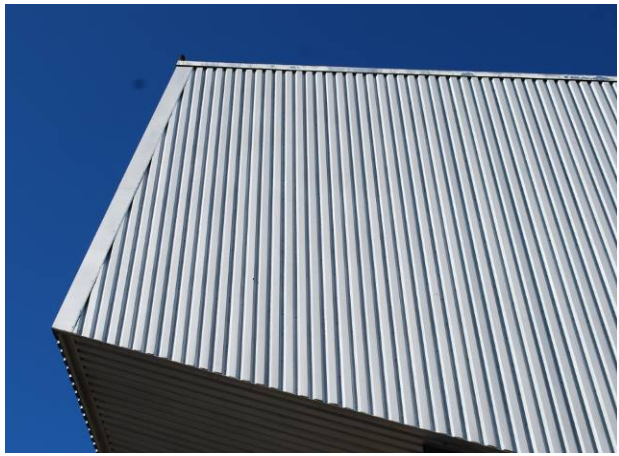
Vertical panel cladding
University of Dayton Arena (1969)
1801 S. Edwin C. Moses Blvd., Dayton
MOT-05157-64

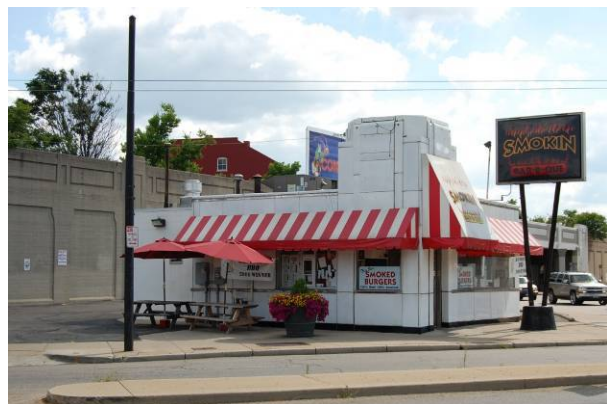
In addition to being lightweight, durable and strong, porcelain enameled steel gave a Modern, streamlined look to both commercial and residential structures. It was used both as decorative panels and as cladding for an entire structure. The Lustron Company was based in Columbus, Ohio, and produced pre-fabricated enameled steel houses from 1947-1950. The surveyed properties featured this material as decorative panels, spandrel panels, and panel cladding.

Panel cladding
White Tower (1940-42)
200 E. Fifth St., Dayton
MOT-05156-15

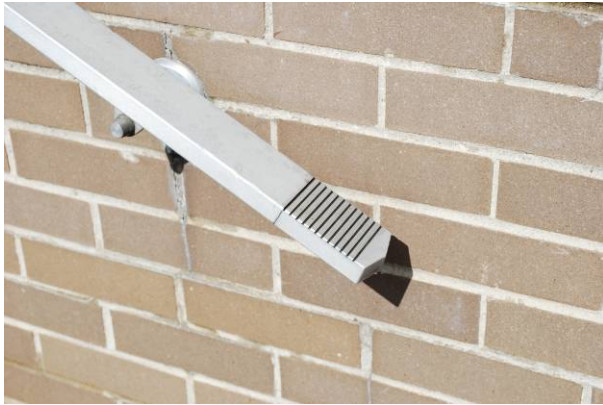
Hand rails

Stainless steel became popular due to its resistance to corrosion, sleek appearance and Modern styling. It was observed in railings and ornamental applications.

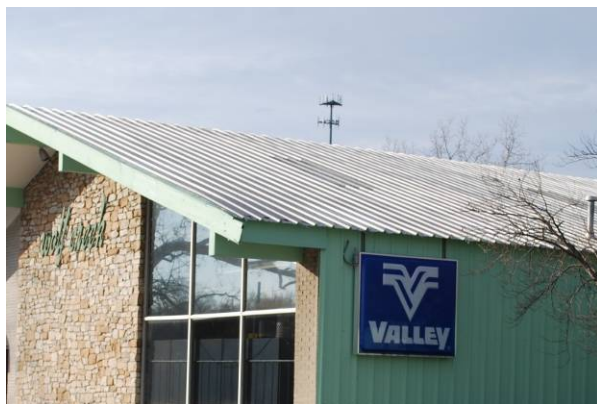
Wolf Creek Company (1962)
6051 Wolf Creek Pike, Trotwood
MOT-05482-08

Steel roofing was observed on several non-residential buildings in the survey. Almost all examples were standing seam roofing.

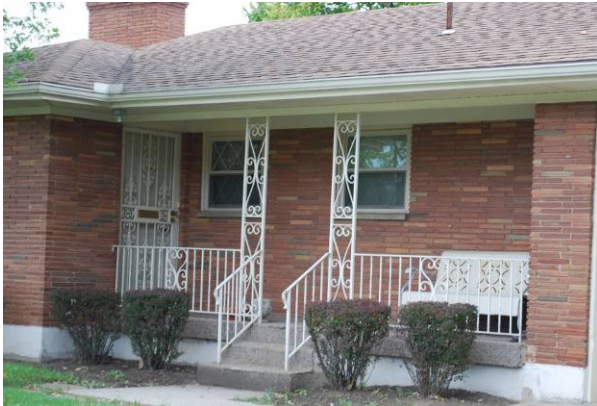
Decorative wrought iron was used extensively in Modern-era residential properties, primarily as porch elements and screen doors. This porch treatment was observed in many types of homes, including Cape Cod cottage, Ranch and homes with no distinctive type or style. The use of decorative wrought iron was found to have extended from the early 1940s until the mid-late 1960s. During the same time period, wrought iron was also used as a railing material in multi-story apartments and motels in the Dayton area.

Porch elements, including screen door
1643 Academy Pl., Dayton (1958)
MOT-05232-36

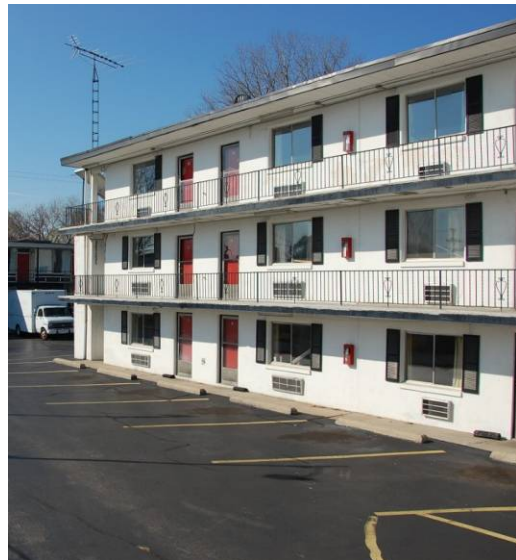
Railings
Dayton Motor Hotel (1950)
1639 N. Keowee St., Dayton
MOT-05403-48

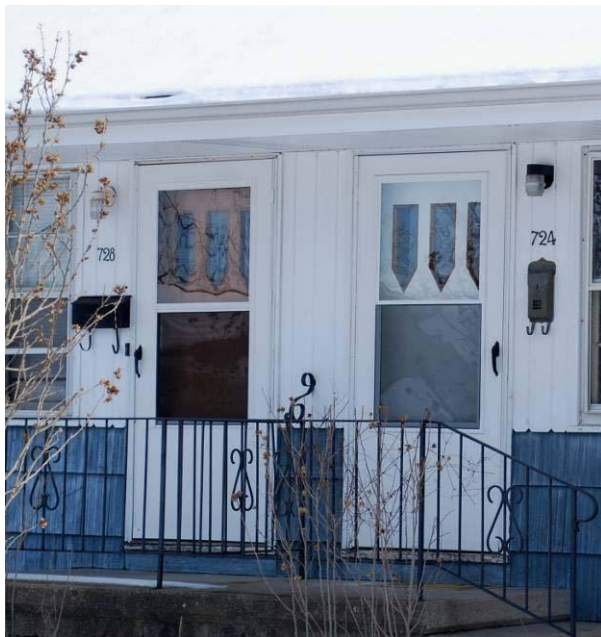
Blonde wooden entrance doors were commonly found on houses of the 1940s and 1950s. These doors usually had one to three lights, often in diamond or rectangular shapes. A large number of houses retain these original front doors, although some have been painted. Double entrance doors were sometimes found on houses built in the 1960s.

Residential entrance – blonde and painted
724-728 Adams St., Fairborn (1954)
GRE-01196-10

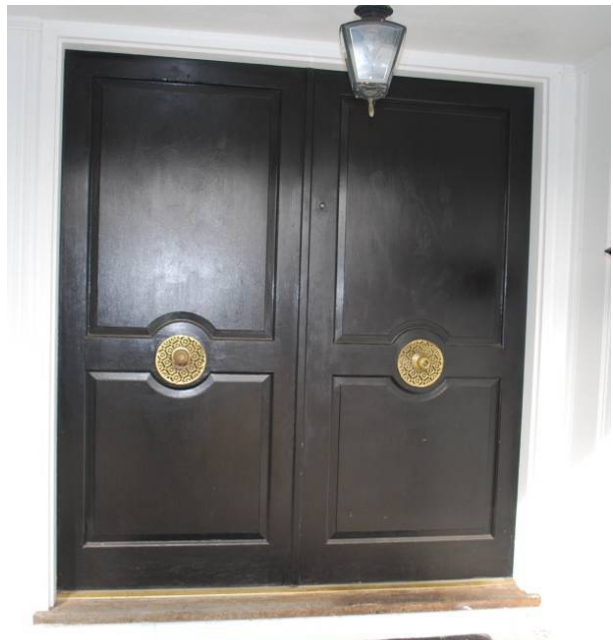
Residential entrance - double
506 W. Sherry Dr., Trotwood (1966)
MOT-05479-08

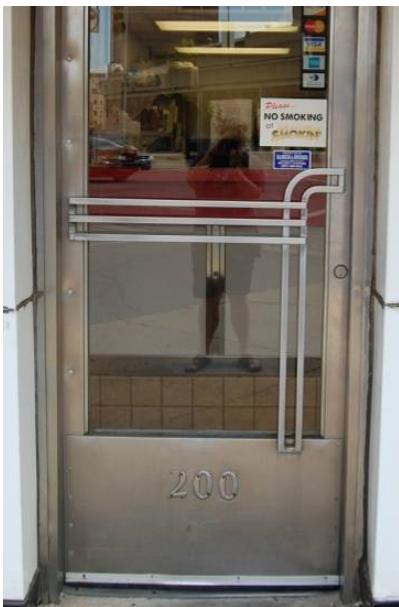
White Tower (1940-42)
200 E. Fifth St., Dayton
MOT-05156-15

Stylized door handles were found on several commercial establishments.

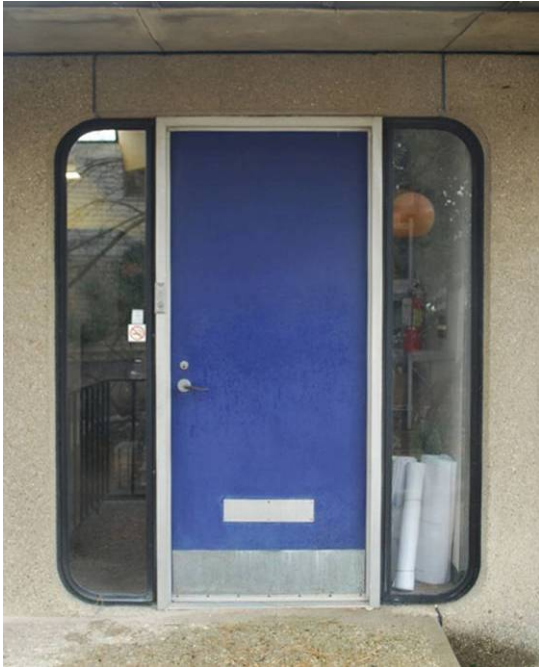
Eugene W. Betz, Architect office (1965)
2223 S. Dixie Hwy., Kettering
MOT-05492-06

Sidelights were more commonly found in residential settings, as most commercial doors were of the storefront type (see below).

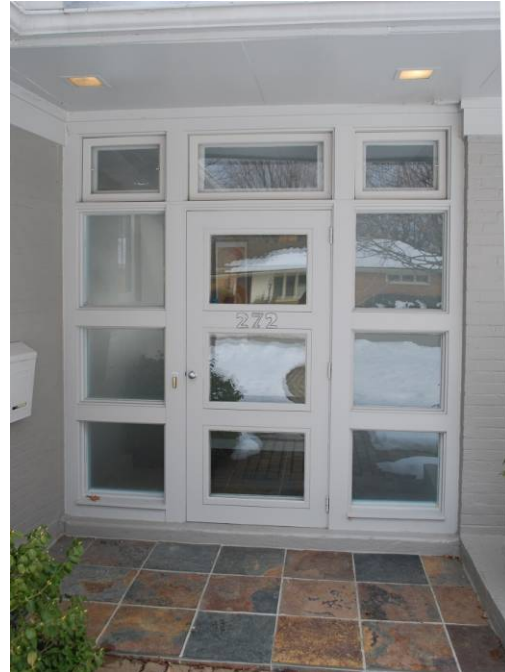
Residential door with sidelights
272 Balmoral Dr., Kettering (1950)
MOT-05543-06

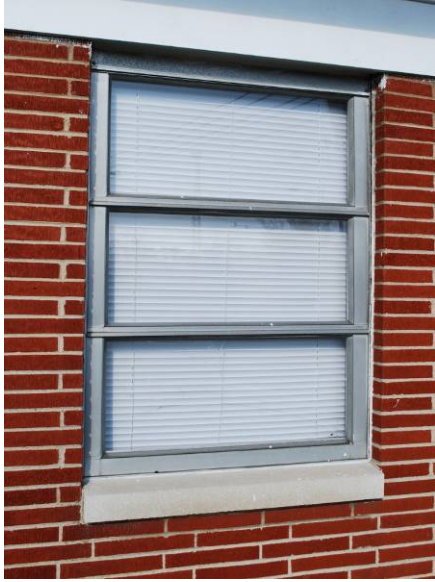
Individual

Awning windows were observed in the Dayton area in both residential and non-residential settings, beginning in the early to mid-1950s and continuing into the early 1960s.

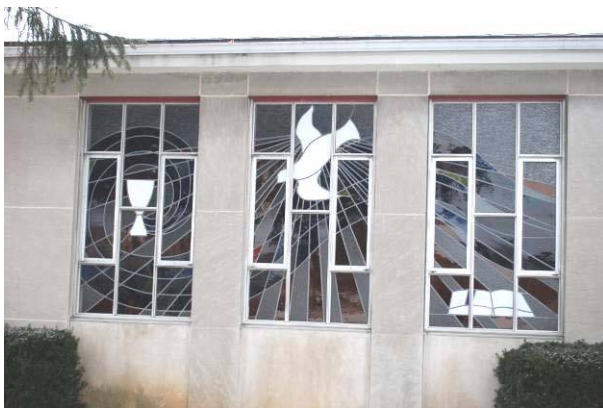
Some traditional art glass was found in Dayton-area churches, but the predominant type of art glass treatment was *dalle de verre*. *Dalle de verre* was developed as a new glass technique in France during the 1930s. Instead of using shapes cut from sheets of colored glass, *dalle de verre* used heavy faceted glass pieces. Originally, the glass pieces were set into a metal mesh that was then covered with a Portland cement mixture. Cement was not very practical, as it made for very heavy panels and had a long cure time. Eventually the metal mesh and cement combination was replaced by a specially developed epoxy resin. Aggregate was seeded into the newly poured resin to create a surface treatment. Also observed were several examples of panels of colored glass set in an offset pattern.

Leaded – traditional pattern
Central Christian Church (1957, 1962)
1200 Forrer Blvd., Kettering
MOT-05504-06

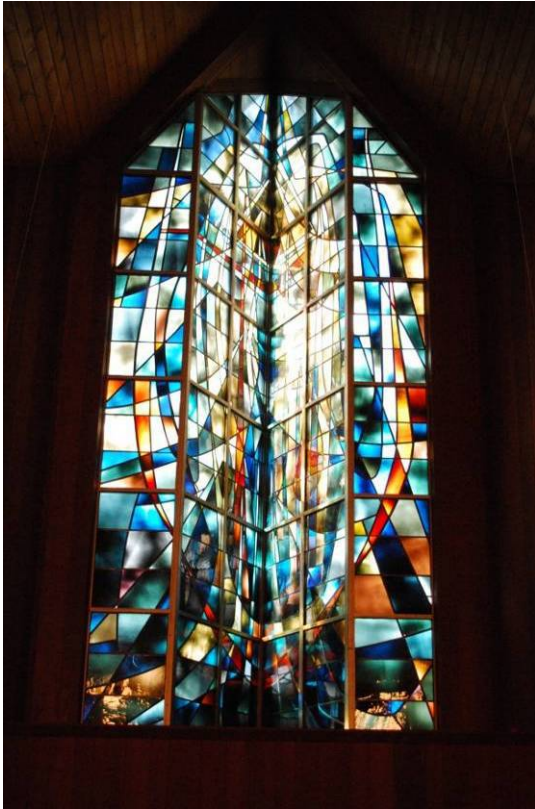
Leaded – abstract pattern
Trinity Evangelical Lutheran Church (1963)
6540 N. Main St., Dayton
MOT-05331-09

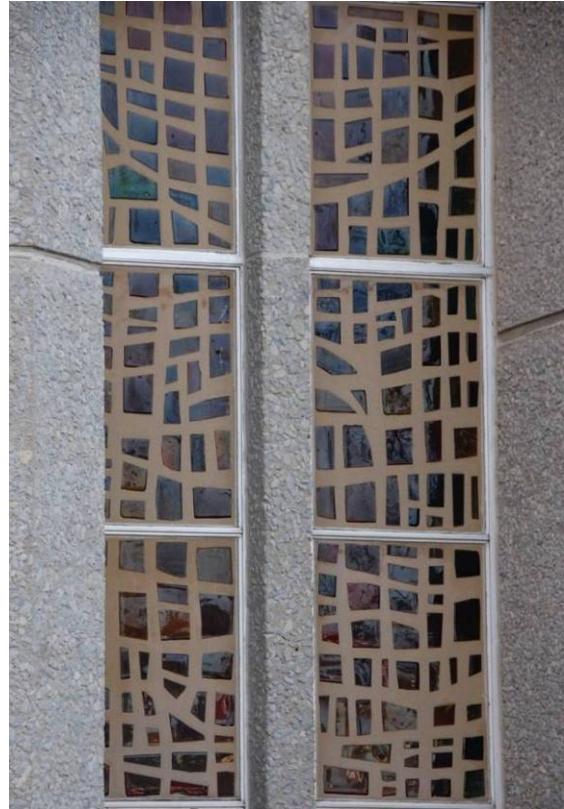
***Dalle de verre* - detail**
Church of the Incarnation (1969)
7415 Far Hills Ave., Dayton
MOT-05593-03

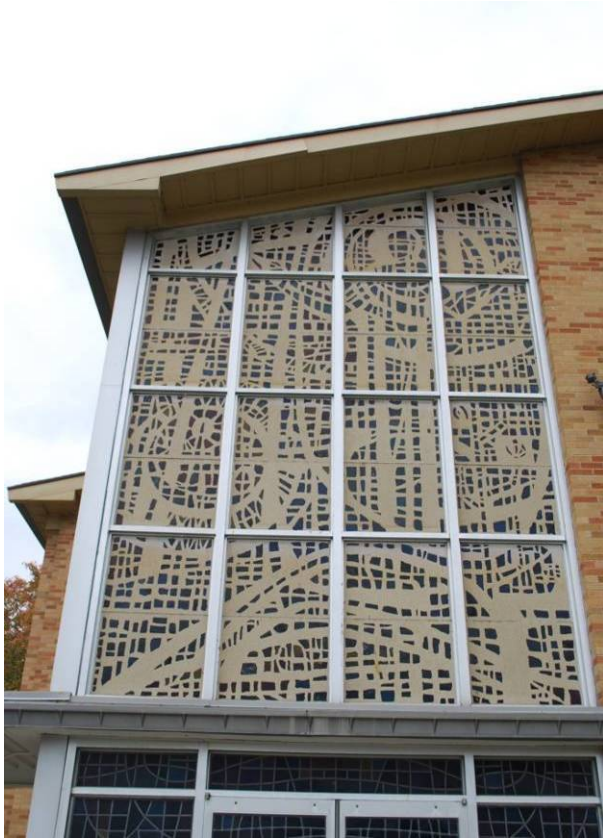
Dalle de Verre - curtain wall
St. Rita's Catholic Church (1964)
5401 N. Main St., Dayton
MOT-05335-09

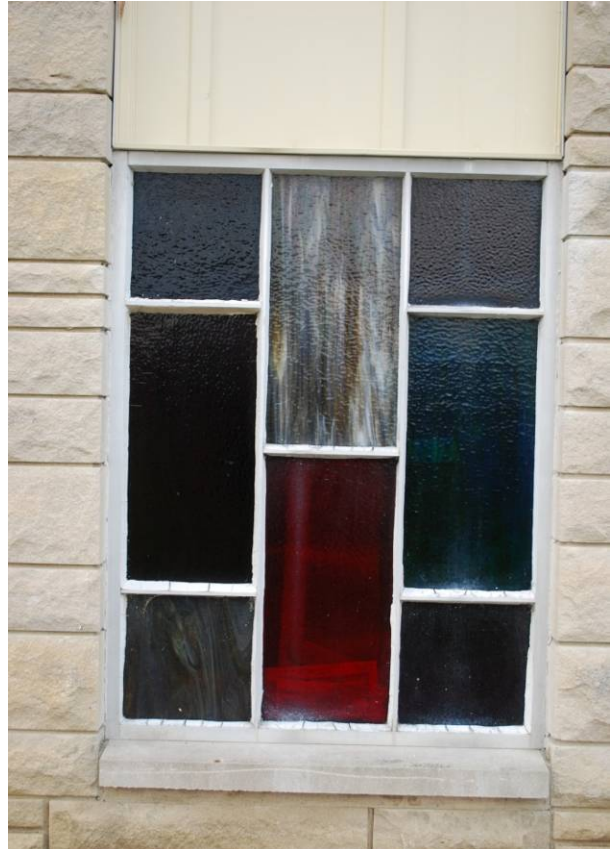
Colored offset lights
First Church of the Nazarene (1964)
7031 N. Main St., Dayton
MOT-05330-09

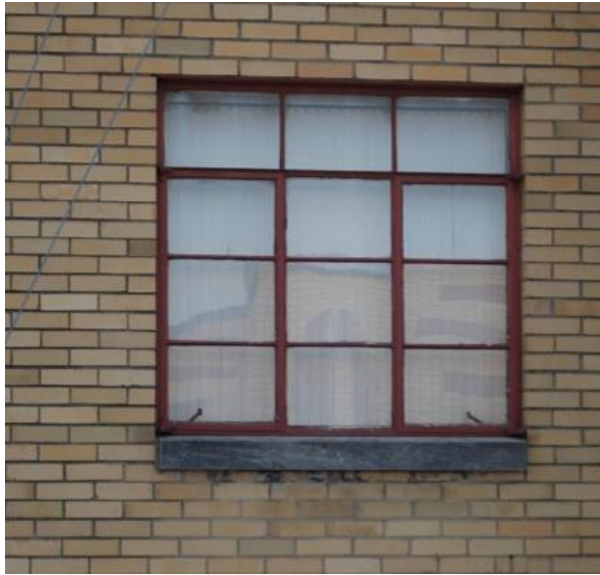
Trailmobile (1949)
1749 Stanley Ave., Dayton
MOT-05505-48

Steel casement windows were observed in both residential and non-residential settings in Dayton. These types of windows were mostly found in buildings dating from the 1940s and 1950s. By the late 1950s, aluminum generally had replaced steel as a window framing material.

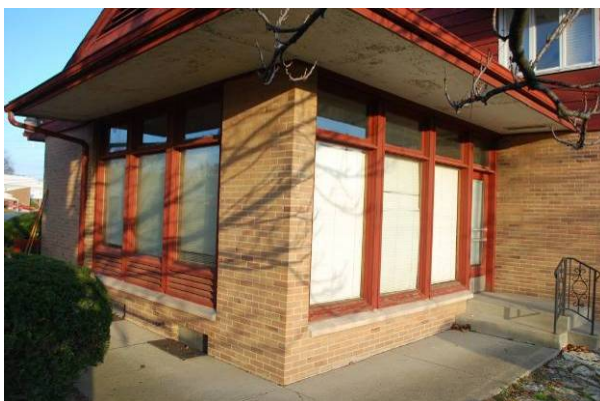
3761-63 Salem Ave., Dayton (1956)
MOT-05265-09

Although this treatment was seen rarely in the surveyed buildings, a similar type of treatment was observed on some picture windows in residential housing (see Picture type).

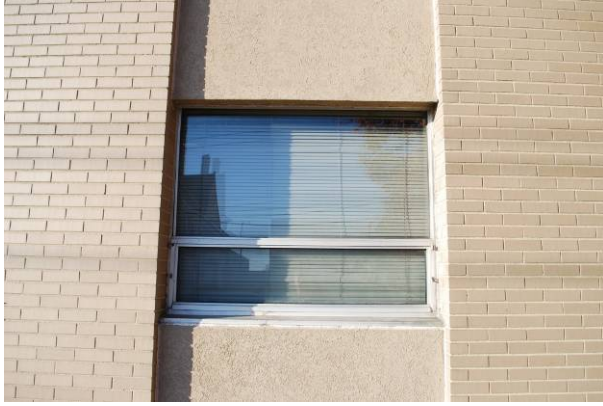
Individual

Hopper windows were found both as individual windows and in groups. They were usually of aluminum and were found from the 1950s through the mid-1960s.

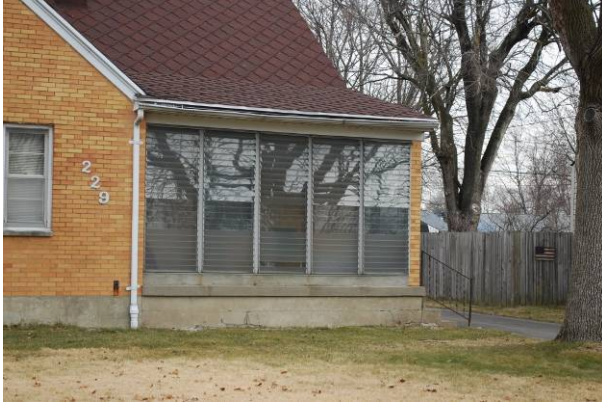
229 North American Blvd., Vandalia (1953,
enclosure date unknown)
MOT-05463-13

Although not common in Ohio due to lack of weather resistance, jalousie windows were found on several enclosed porches.

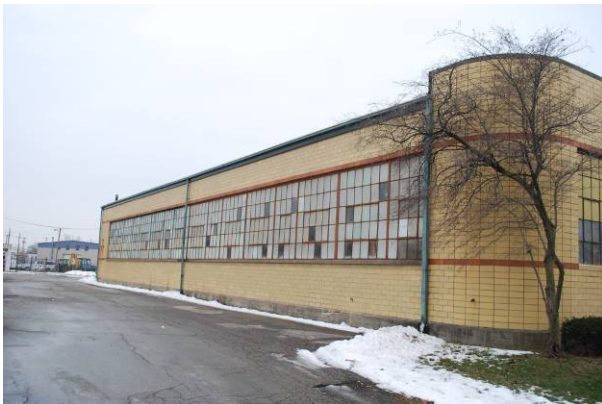
PMF Associates (1946)
1280 McCook Ave., Dayton
MOT-05508-48

Steel windows were found on earlier 1940s buildings. The survey results indicate that steel had been replaced with aluminum-framed windows by the mid- to late 1950s.

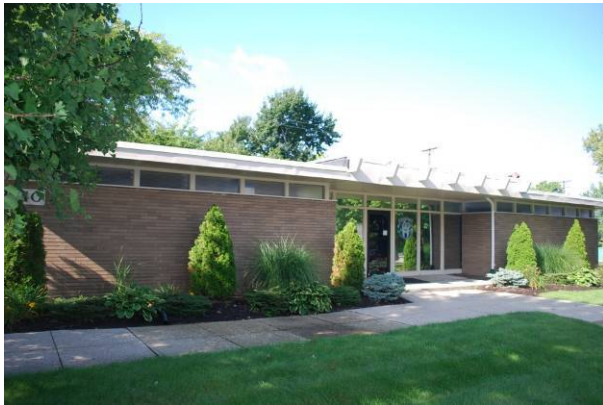
Clerestory windows were a common feature in the Modern style. They were found in both residential and non-residential properties in the survey, beginning in the 1950s and continuing through the rest of the period.

Continuous
Aggarwal Dental Center (1957)
2640 Salem Ave., Dayton
MOT-05163-36

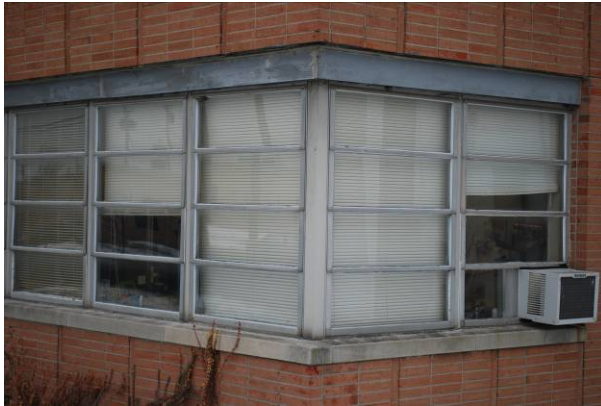
Horizontal banded windows were common features of the Modern era. They were found primarily on non-residential buildings from the early 1950s through the mid-1960s. Most of these windows were aluminum-clad, although steel-clad examples were occasionally found.

Continuous - turning corner
General Diaper Service (1955)
1407 Stanley Ave., Dayton
MOT-05506-48

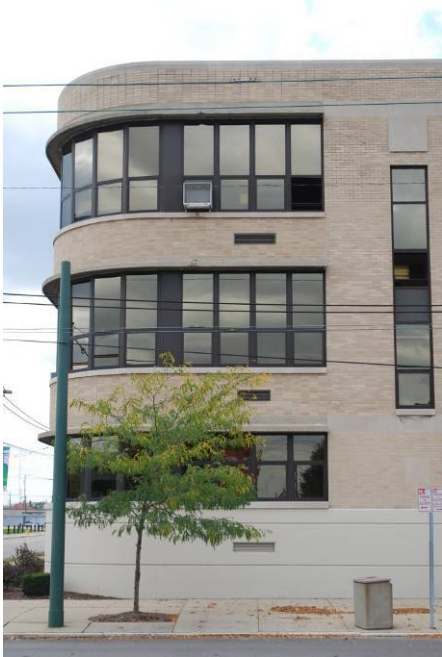
Turning curved corner
Chaminade High School (1951)
505 S. Ludlow St., Dayton
MOT-05207-56

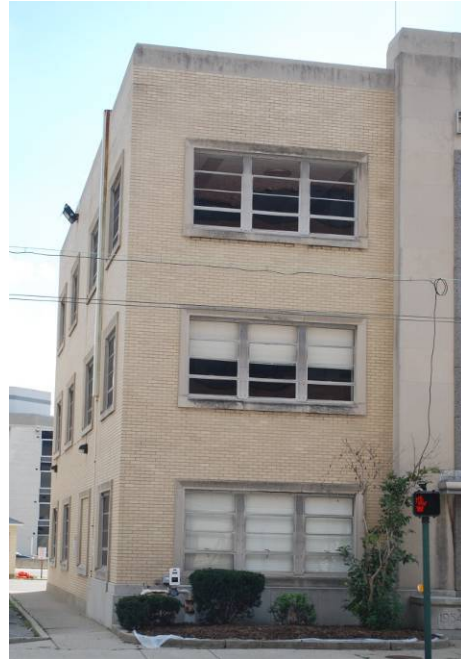
With surround
Board of Education Building (1954)
348 W. First St., Dayton
MOT-05150-15

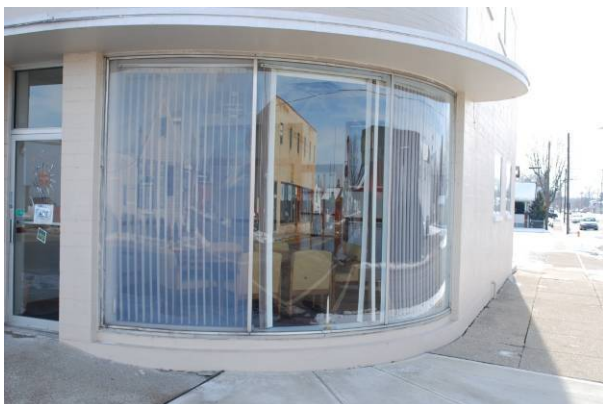
440 W. Main St., Fairborn (1949)
GRE-01192-10

Only one curved glass window was observed in the survey area. Rounded corners in other Art Moderne buildings were usually filled with glass block.

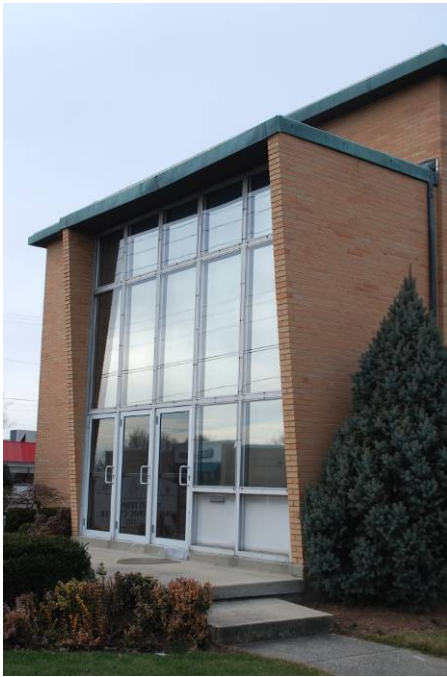
Glazed aluminum curtain wall was one of most prominent stylistic elements of Modern design. Its clean lines reflected the “machine aesthetic” that was a common theme of Modern styling. Framing systems featured prominent use of aluminum. Spandrels were comprised of many different types of materials, including porcelain enamel, exposed aggregate reinforced concrete, and ceramic tile. Curtain wall systems were found in many non-residential buildings in the Dayton area.

With entrance system
Kettering Masonic Center (1958)
2251 S. Smithville, Kettering
MOT-05503-06

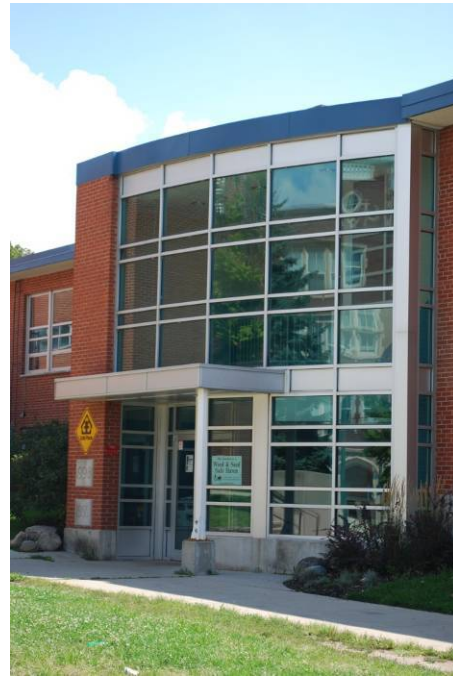
With entrance system
Bomberger Recreation Center (1955)
1306 E. Fifth St., Dayton
MOT-05161-57

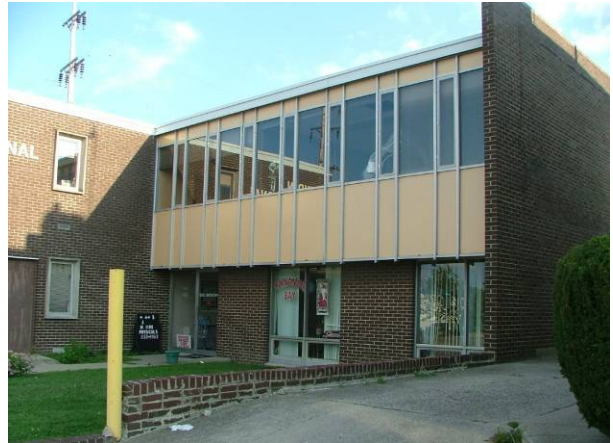
With porcelain enamel metal spandrel panels
Linden Professional Building (1964)
2838 Linden Ave., Dayton
MOT-05200-61

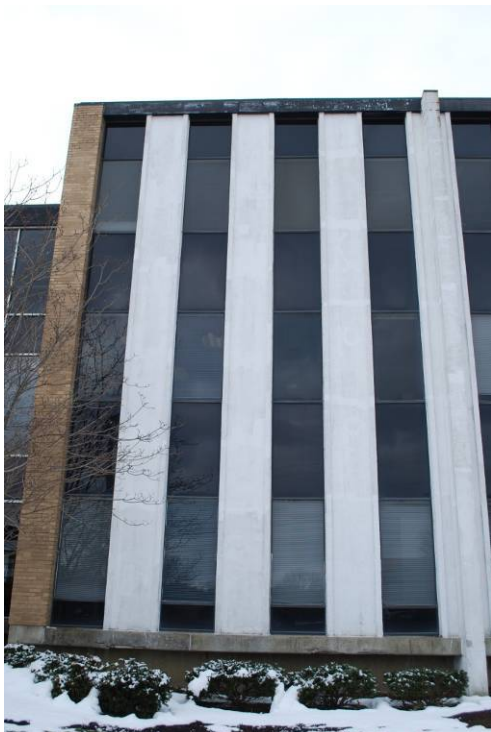
With vertical concrete panels
Financial South Office Building (1968)
5335 Far Hills, Kettering
MOT-05494-03

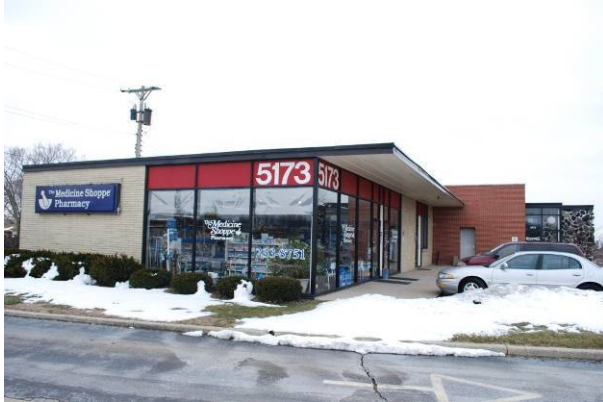
Storefront systems consist of glass entrance doors with metal framing that are surrounded by glass panels. These systems were found not only on retail establishments, but as entrances to churches, schools, and office buildings.

With porcelain enamel metal spandrel panels
Brandt Medical Center (1963)
5173 Brandt Pike, Huber Heights
MOT-05520-14

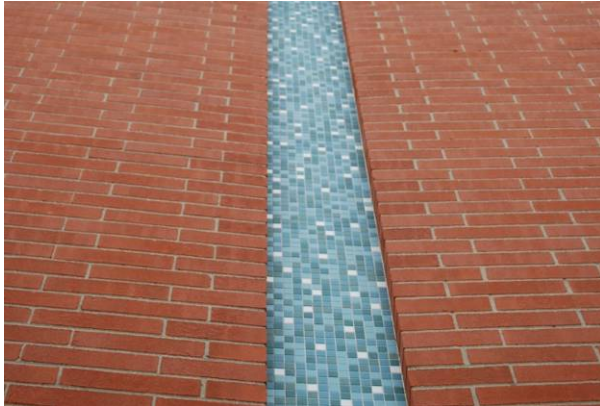
Accent on facade

Ceramic tile was used to provide color accents. Mosaic tile was the most frequent type observed, usually in school or church settings.

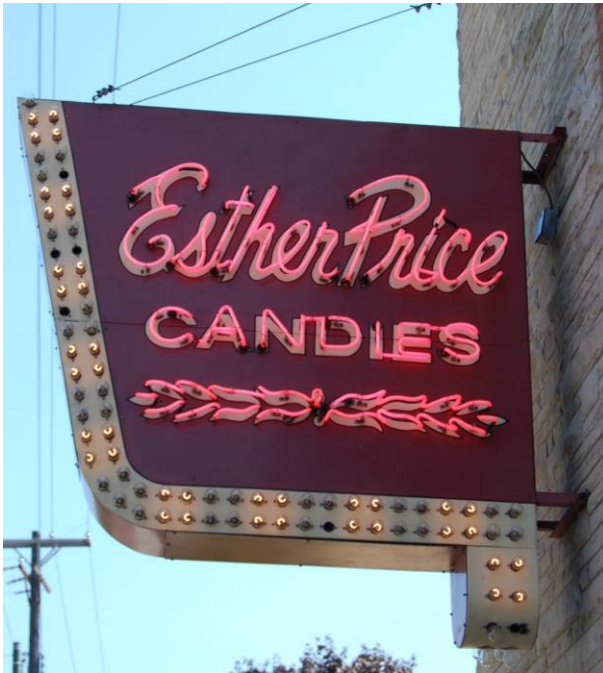
By 1940, exposed light bulb and neon signs had been in use for many years. Both types featured lights attached to a hollow-core metal base. Neon was popular due to the malleable quality of the neon tubing and wide variety of colors. Despite the popularity of neon, the exposed light bulb remained an important element of mid-20th-century signs. Many sign manufacturers took advantage of both lighting technologies well into the 1960s. Both neon and exposed light bulb signs were found in the survey.

Combination neon and exposed light bulb
Esther Price Candies (1952)
1709 Wayne Ave., Dayton
MOT-05195-60

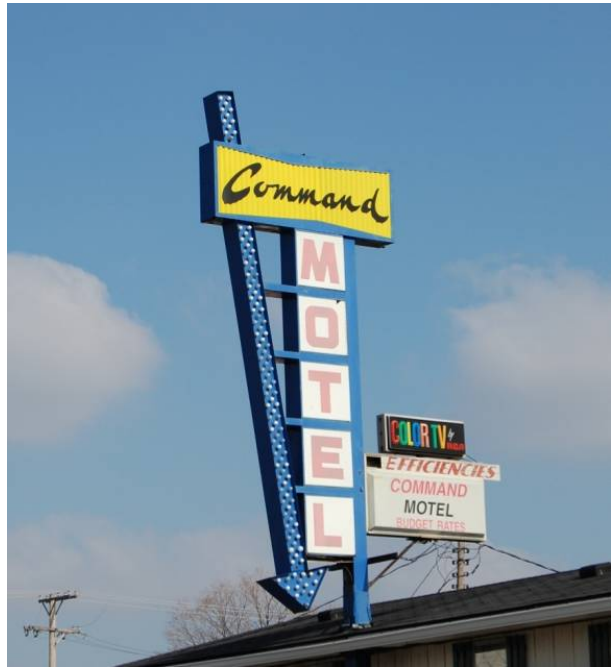
Exposed light bulb
Command Motel (1960)
130 N. Broad St., Fairborn
GRE-01206-10

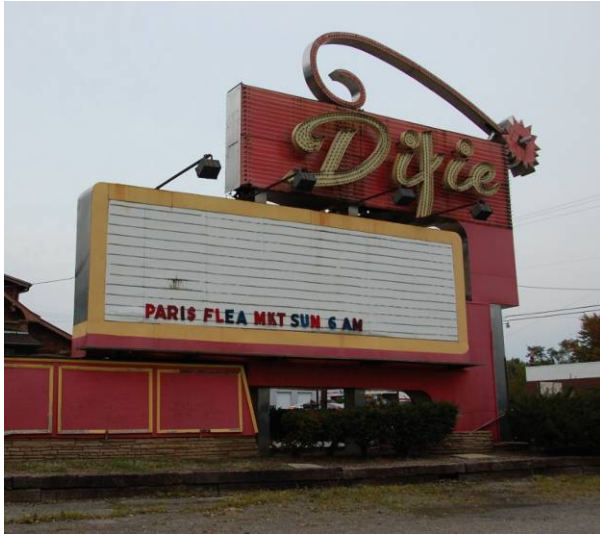
Neon with plastic panel
 Dixie Drive-in (1959)
 6201 N. Dixie Dr., Dayton
 MOT-05413-09

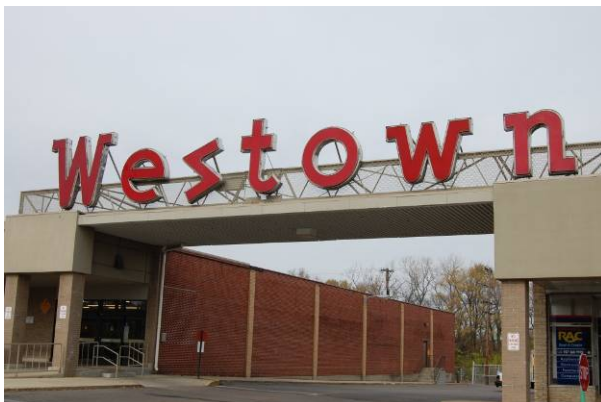
Plastics for signs began to be used in the late 1940s and remained a staple of sign construction through the 1970s. Plastic panels, whether or not back-lit, also provided the ability to create a sign's wording with individual letters. This allowed signs to take on even greater dynamic proportions and irregularity in shape. Hollow-core metal sections were sometimes intermixed with plastic hollow-core sections. A number of period plastic and metal hollow core signs were observed in the survey area.

Plastic hollow core – individual letters
 Westtown Shopping Center (1957)
 4227 W. Third St., Dayton
 MOT-05300-32

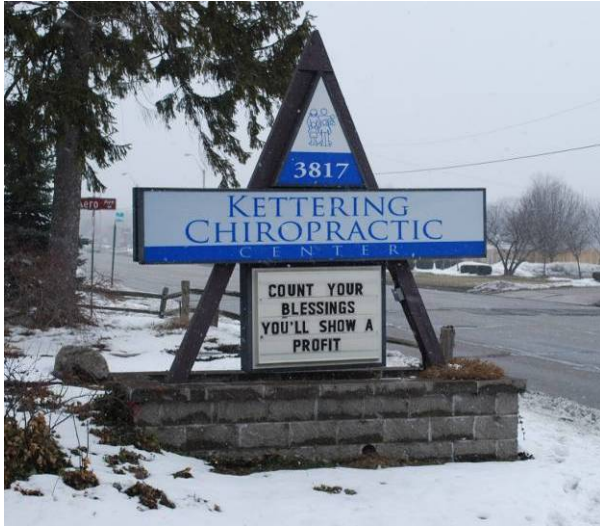
Plastic hollow core – detached with planter
 Charles Davis Florist (1968)
 3817 Wilmington Pike, Kettering
 MOT-05501-06

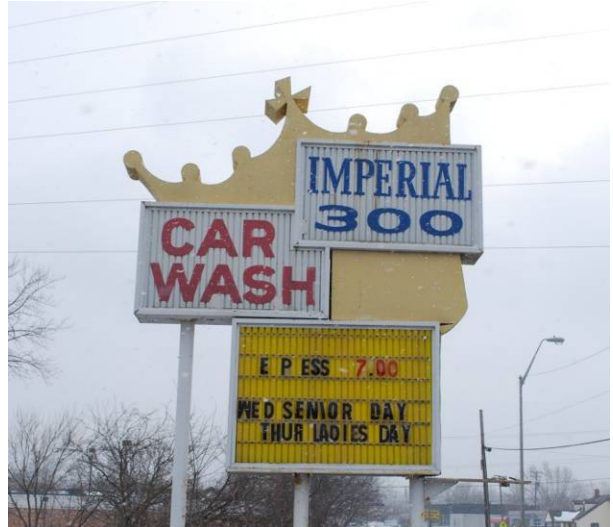
Plastic and metal hollow core – pole mounted
 Imperial 300 Car Wash (1966)
 2536 Wilmington Pike, Kettering
 MOT-05493-06

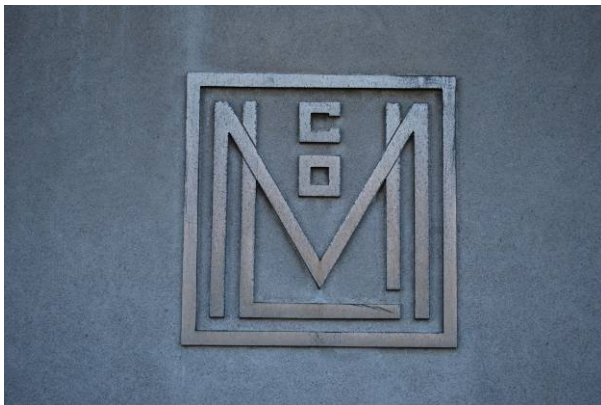
Ornamental metal was attached to the building and contained simply a name and/or logo. Though not common, several examples of this type of signage were found in the survey area.

Plaque
 Metropolitan Life Insurance Co. (1959)
 3760 Salem Ave., Dayton
 MOT-05314-09

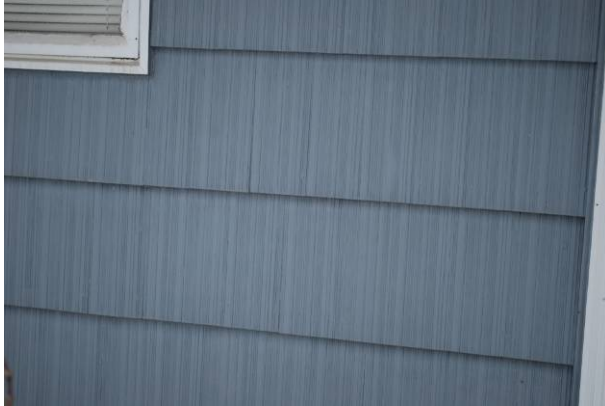
Wood grain siding

Although asbestos and asphalt shingles had been produced since the early 20th century, wood grain siding shingles became popular in the 1940s and 1950s. This type of siding was found on a few houses in the survey area. Asphalt roofing shingles were found on nearly every house in the survey. A few examples of patterned roof shingles were observed.
