1. Name of Property	
Historic name: <u>Tawney Musser Farm</u> Other names/site number: <u>N/A</u>	
Name of related multiple property listing: N/A	
(Enter "N/A" if property is not part of a multiple pro-	operty listing

2. Location Street & number: 10495 Black Diamond Road City or town: Marshallville State: Ohio Not For Publication: N/A Vicinity: x	County: Wayne
3. State/Federal Agency Certification	
As the designated authority under the National Hist	oric Preservation Act, as amended,
I hereby certify that this X nomination required the documentation standards for registering propertions and meets the procedural and professional results.	les in the National Register of Historic
In my opinion, the property _X meets does I recommend that this property be considered signif- level(s) of significance:	<u> </u>
national statewide X le Applicable National Register Criteria:	ocal
X A B $X C$ $X D$	
Boulova Polucy DSHPO for Inven	tory & Registration 1/19/2021
Signature of certifying official/Title:	Date
State or Federal agency/bureau or Tribal Go	vernment
In my opinion, the property meets does	not meet the National Register criteria.

Resource #1 on site plan: TAWNEY MUSSER FARMHOUSE, 1870

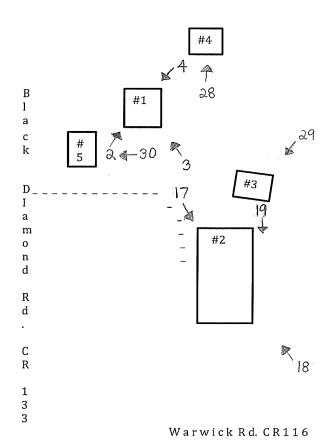
#1 Farmhouse (C)
#2 Barn (C)
#3 Springhouse (C)
#4 Tool Shed (C)
#5 Metal Shed (NC)

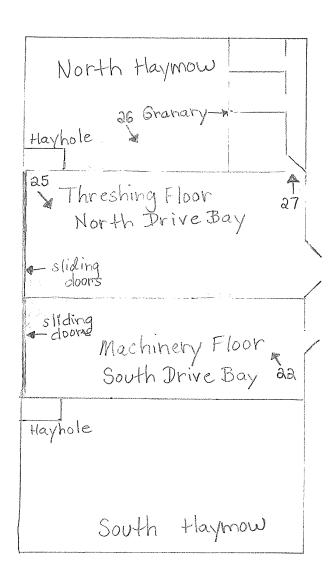
N
Tawney Musser
Barn
Main Floor
Scale:
Icm=4ft

The main barn floor follows the typical standard plan of the Pennsylvania bank barn, consisting of four bays including the threshing floor (Photo #25). The north and south end bays are haymows measuring about 22' each, with a hay hole located at the rear along the drive bay. The center drive bays could have functioned as both threshing and machinery floors. Wooden floorboards measure 2" in thickness and vary in width between 9"-18". Measuring 18½' the north drive bay is distinctly the threshing floor, with a double row of floorboards and large double hinged wind doors in the front wall. There are threshing walls of horizontal boards about 3' high between the threshing floor and the adjacent bays. The south drive bay measures about 15', with a single row of floorboards and a man door in the front wall.

It is rare that the original 'staging' remains in place above the east and west ends of the threshing floor, consisting of five hewn timbers across the principle tie beams with planks providing a 'stage' on which to stand and pitch hay onto the haymow on either side as the haystack grew higher. The south drive bay would have been used as a third haymow after the north and south haymows were filled (Photo #26). There are three original built-in ladders with four rungs each leading up to the principle tie beams above the drive bays, but the center one was removed. It is interesting to note that the original bark remains on numerous hewn beech timbers, for example the 'staging' timbers and basement joists.

The forebay is continuous with the threshing floor and haymows except for the north haymow where the granary (Photo #27) is located. The granary is partitioned from the north haymow along the east side, the warmest and driest side with circulation of fresh air below. The granary measures 22½ x 11' x 7½ and houses three grain bins (10' x 9', 6' x 9', 6'2" x 9') with two windows. The bin boards that slide down to close each bin remain intact.

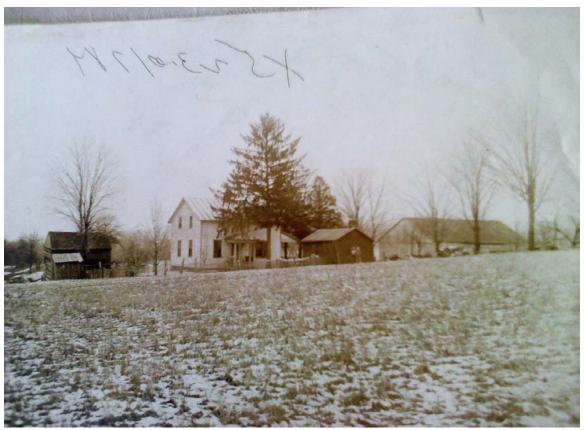
Figure 7: Tawney Musser Farmstead: Log Cabin, Smokehouse, Farmhouse, Summer Kitchen, Barn ca. 1910-1915, view looking East

There are several structures that once were associated with the farmstead but no longer remain. A log cabin, smokehouse, summer kitchen, chicken house, two corn cribs, two brooder houses, an outhouse, and a garage have deteriorated or been removed or repurposed. There was a sawmill site located east of Black Diamond Road and northwest of the homestead near a row of pine trees that are still standing today. The old orchard was located northeast of the log cabin and farmhouse. (See sketch map ca. 1910-1930).

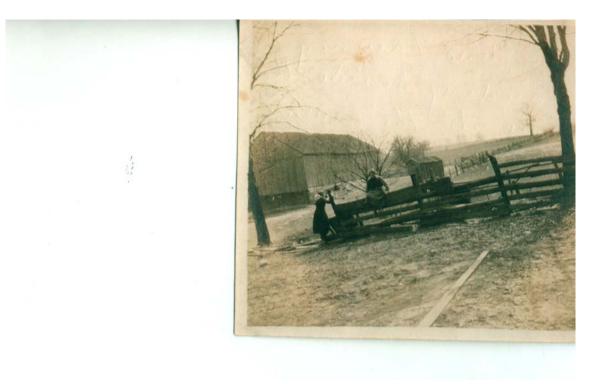
Figure 9: Barn and Corn Crib ca. 1915-1920

Several photographs of the barn taken ca. 1910-1920 reveal several details. Originally all three sandstone foundation walls went up to the main barn floor. Several rows of sandstones were removed from the north wall, along the west wall below the north haymow, and probably from the south wall. Vertical wood siding with additional timber framework replaced the sandstones. Basement windows may have been added to provide more light. The wood siding was likely replaced at this time, with the addition of a single, small square 4 sash window and 3 ventilators to each gable end for additional light and circulation. Interior ladders were added to the gable ends to access these windows, which slide open. A ventilator near the barn floor in the northwest corner of the north haymow was also added.

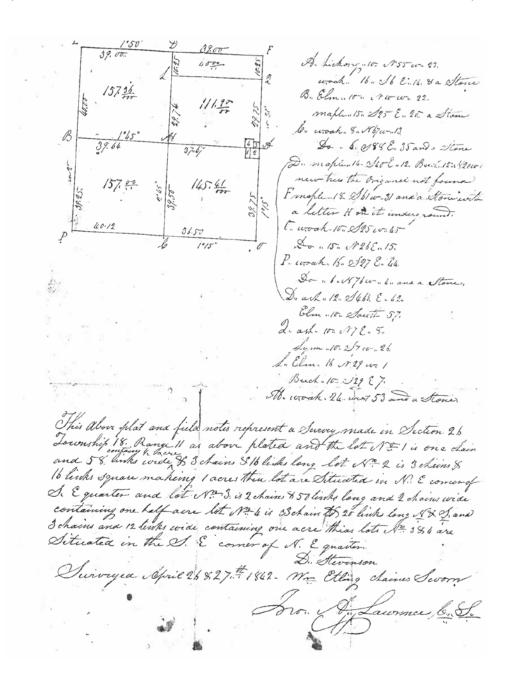
Figure 19: John Tawney's plat of land of Chippewa Township recorded page 162 Surveyed April 26 & 27, 1842

By 1840 the population of Wayne County had reached 36,015.¹² In 1842 John built a bank barn with the help of son Abraham, the foundation having been made of straw, clay and large stones.¹³ A land survey of the farm from April 26 & 27, 1842 reveals that standing timber on the farm consisted of beech, elm, hickory, maple, white oak, ash, and sycamore trees. John purchased another 24 acres of land about a half mile south of the farmstead from Abram Keefer and wife on September 11, 1847.¹⁴
